STORM WATER

THE SHUSWAP TRAIL ALLIANCE SHUSWAP NORTH OKANAGAN RAIL TRAIL STORMWATER MANAGEMENT REPORT

October 28, 2020

Project #: 1928-011

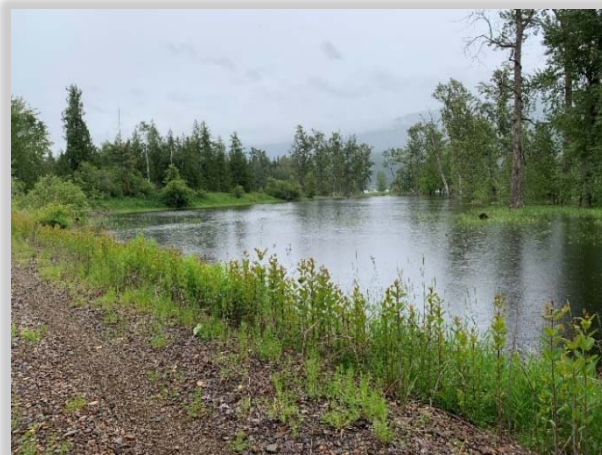
Figure 3.1 – Km 25.00 – Standing water

- Km 25.00 – Culvert possibly submerged and not visible due to high standing water, see **Figure 3.1**.
- Km 27.60 – Identified as potential culvert location. Two (2) 100mm PVC drainage pipes from Sure Crop Feeds found draining into the ditch at back of property. No culvert located.
- Km 32.75 – Identified as potential culvert location. Catch basin located behind North Enderby Timber Mill. Catch basin outfall not located, could be draining into rock pit. No culvert located.
- Km 34.60 – Identified as potential culvert location.
- Km 48.60 – Identified as Culvert #13 on WWAL map set, but not shown on USL kmz map.

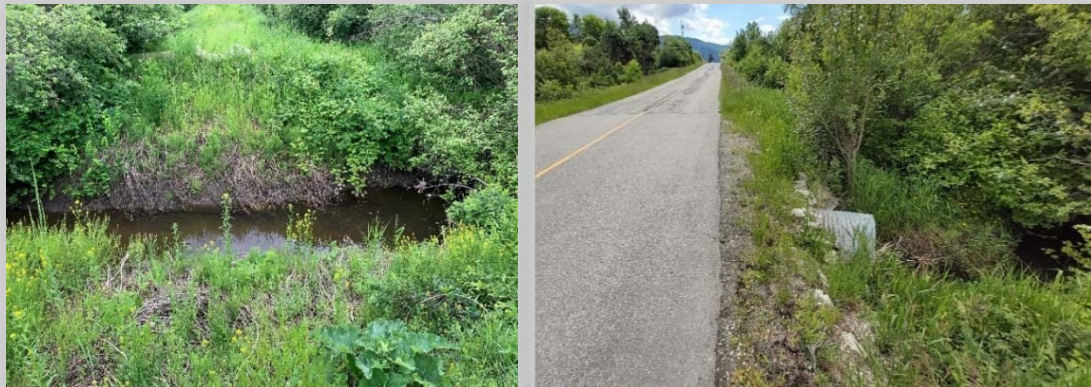
Figure 3.3 – Km 43.14 – Hussard Creek

At km 43.14, the removed culvert was located at Hussard Creek. A short distance upstream from the rail trail a 1500mm CSP culvert crosses Stepney Road. Therefore, the replacement culvert at km 43.14 should be of similar size/capacity.

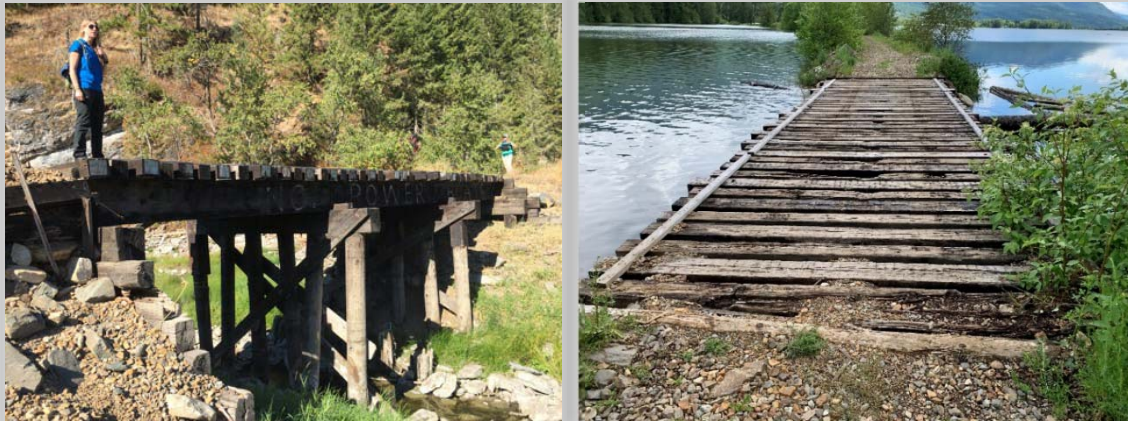
Figure 3.4 – Km 14.81 – Bridge #1 – Left: Fall 2017 (USL kmz map) Right: Spring – June 08, 2020

Debris consisting of mostly logs has built up southwest of the bridge at Rosemond Lake and may pose a safety hazard to the bridge.

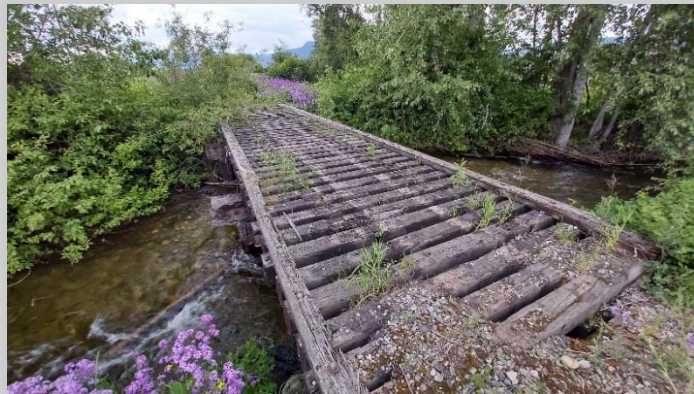
Figure 3.8 – Km 48.86 – Bridge #4

Bridge #4 crosses Fortune Creek at km 48.86, see **Figure 3.8**. The bridge spans approximately 13.60 metres, is about 2.95 metres wide and has two bridge piers. The elevation of the bridge deck is 362.84.

At the time of inspection on June 10, 2020, Fortune Creek at Bridge #4 consisted of fast flowing water, making it unsafe to enter the water. Approximate channel cross section and water depth were obtained from shore. The water level elevation on June 10, 2020 was 360.91, which corresponds to a freeboard of 1.93 metres to the top of decking. Water flow depth was about 0.43 metres.

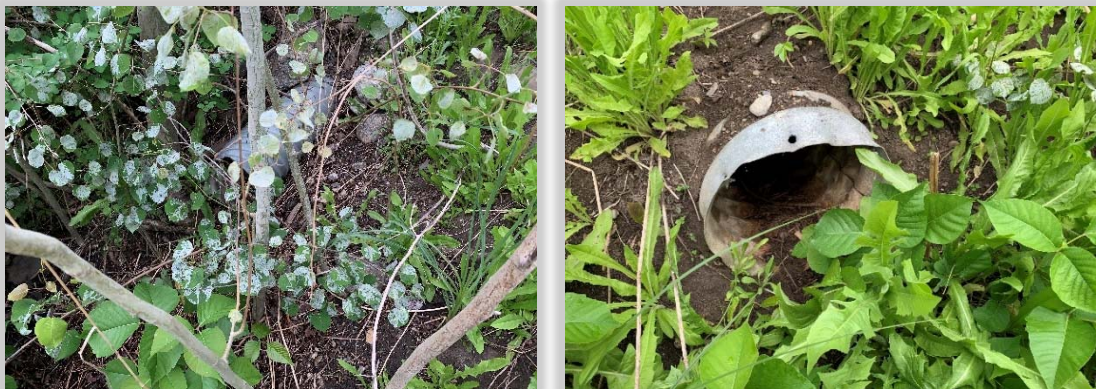
Figure 3.9 – Km 37.10 – 200mm and 300mm CSP Outfalls

- Km 37.10 – One (1) 200mm CSP and one (1) 300mm CSP outfall were located within a few metres of each other. These outfalls drain into the west ditch of the rail corridor and at the time of inspection were dry. See **Figure 3.9**.

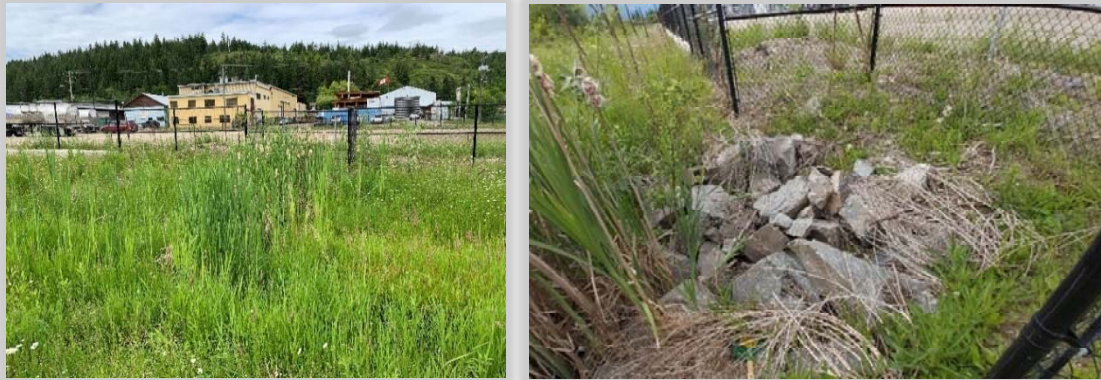
Figure 3.10 – Km 37.25 – Assumed Outfall

- Km 37.25 – An outfall pipe was not located. However, rip rap and reeds were observed indicating presence of water. A manhole cover was observed on the other side of fence. Therefore, it was assumed that an outfall is located at that location. See **Figure 3.10**.

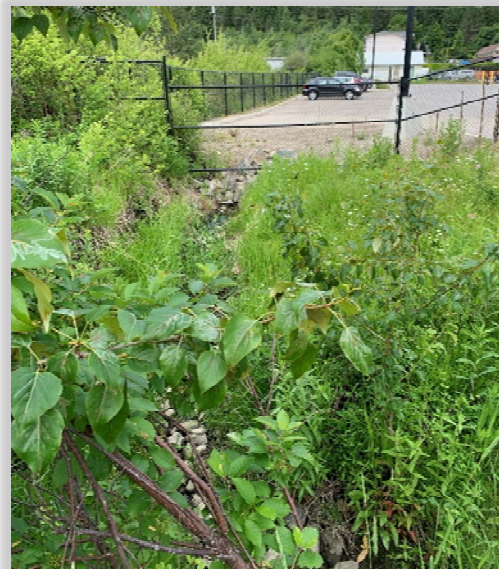
Figure 3.11 – Km 37.40 – Assumed Outfall

- Km 37.40 – An outfall pipe was not located. However, rip rap and flowing water was observed. Therefore, it was assumed that an outfall is located at that location. See **Figure 3.11**. The water from the outfall is draining towards the 600mm culvert at km 37.36.

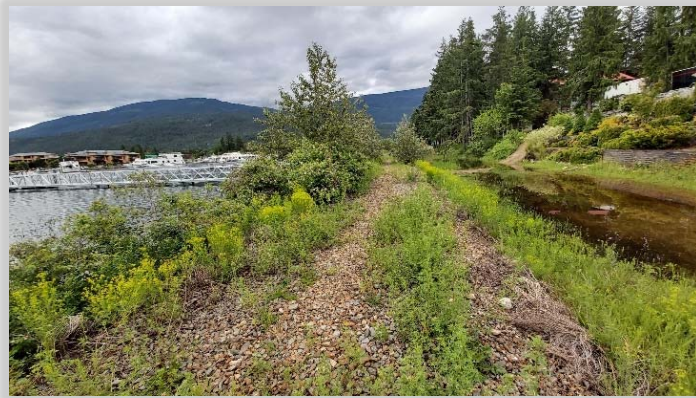
Figure 3.12 – Km 0.00 – 14.80 – Standing water

- Km 0.00 – 14.80 – Standing water was observed within ditches in low lying areas along the west side of the rail trail. Based on our observations, this water is associated to groundwater/lake water backing up from Mara Lake due to the rail corridor's close proximity to Mara Lake and the ditch bottom elevations being below current lake levels. See **Figure 3.12**.
- Km 1.70 – Standing water in west ditch.
- Km 3.30 – Significant sediments and water in ditch. Possibly previous flooding. See **Figure 3.13**.
- Km 15.20 – 15.80 – Lake water spilling over the rail bed at an approximate depth of 0.15m. See **Figure 3.14**.
- Km 20.50 – Standing water in west ditch.

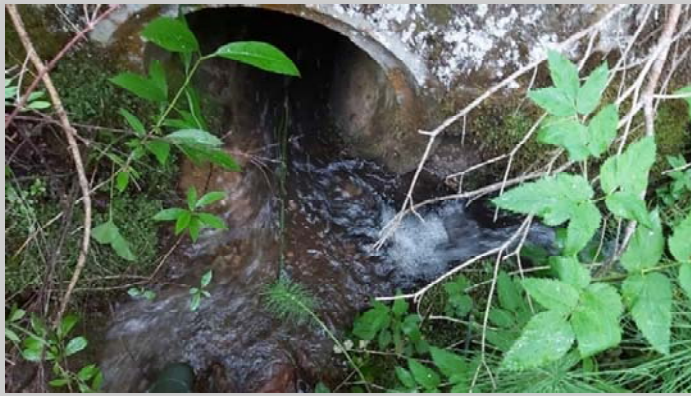
Figure 4.3 – Km 7.70 – Unnamed Stream diverted through ditch to Culvert #4

The field investigation findings indicate that the majority of storm infrastructure assessed provide drainage of ditches along the rail corridor. However, some of these ditches intercept streams and divert stream flows to culverts in the vicinity. This has been observed at km 7.70 (Culvert #4), see **Figure 4.3**, and km 40.00 (Culvert #23). Both streams are minor drainage courses.

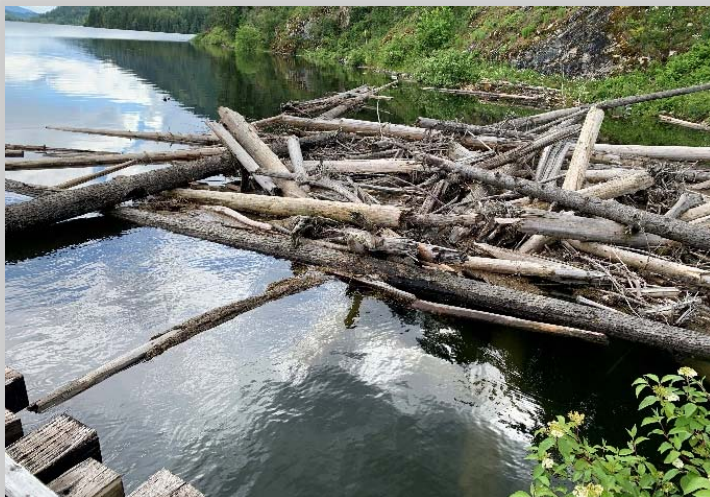
Figure 5.3 – Debris at Bridge #1

However, debris consisting of mostly logs has built up southwest of Bridge #1 at Rosemond Lake and may pose a safety hazard to the bridge, see **Figure 5.3**. Therefore, we recommend removing the debris or relocating the debris to higher ground to prevent potential damage to the bridge.

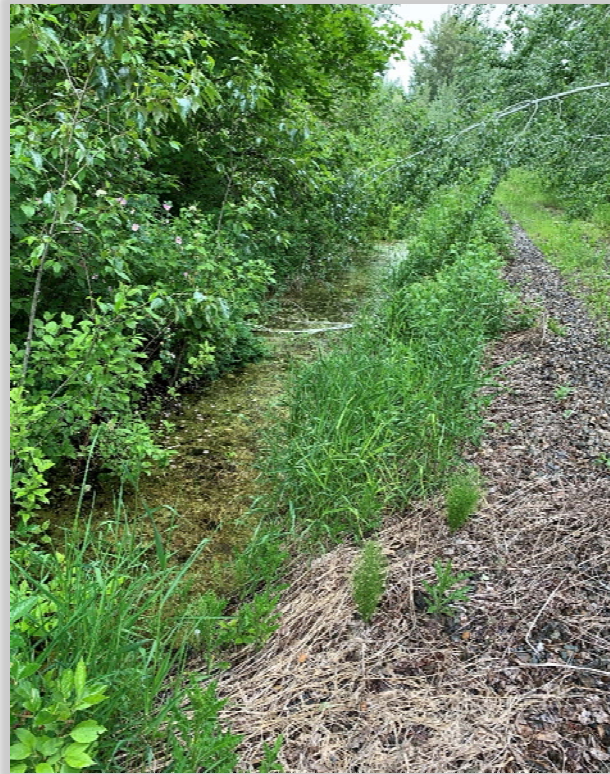
**Figure 5.4 – Km 24.30 – Standing water
(proximity to Violet Creek)**

- Km 24.30 – Standing water in west ditch. Corresponds with the location of Violet Creek, a major drainage course.
- Km 25.00 – High standing water on both sides of the rail corridor, see **Figure 3.1**.
- Km 35.00 – Standing water in ditch between Hwy 97 and the rail corridor.
- Km 38.00 – 40.10 – Standing water in ditch.
- Km 42.70 – 43.00 – Standing water in ditch.
- Km 49.00 – 50.00 – CP owned section of the rail corridor was also inspected. No drainage issues were observed along this section.

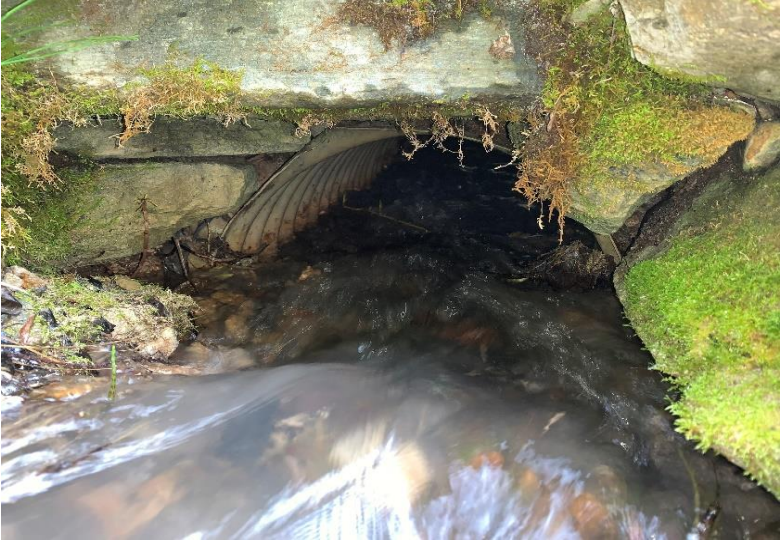
Date Inspected:		June 8, 2020	
		WWAL ID:		Culvert #1	
		CULVERT:			
		Diameter (mm):		400	
		Material:		CSP	
		Length (m):		6.0	
		Mitered:		n/a	
		Projection Length (m):			
		US:	n/a	DS:	n/a
		Invert (m):			
US:	349.16	DS:	no shot		
Top of Rail Bed (m):		350.17			
Cover (m):		0.61			
Rail Bed Condition:		Good			
Pipe Condition:		Fair Some visible corrosion on sidewalls, filled 50% with rocks			
Inlet:		Filled 50% with rocks			
Outlet:		Filled 50% with rocks, tree growing on top of culvert			
Headwall:	US:	Rocks utilized as headwall			
	DS:	Rocks utilized as headwall			
Rip Rap:	US:	n/a	DS:	n/a	
Trash Rack:		n/a			
STREAM:					
Flow Type/Source:		Ditch flow - draining towards Mara Lake			
Water Depth (m):		0.10	Water Level Width (m):		0.60
High Water:		No	Scour:	No	Debris:
				No	Aggradation:
					Yes
COMMENTS:					
Discolouration/possible high water mark about 0.05m above current water level in culvert					
REPAIR:

Repair Priority:		Medium			
Repair/Action Item:		Remove rocks from culvert

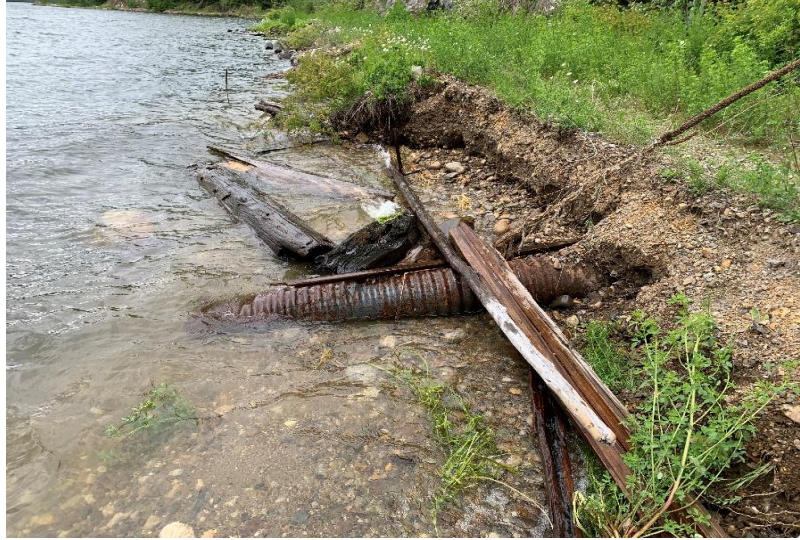
Date Inspected:		June 8, 2020	
	WWAL ID:		Culvert #2	
	CULVERT:			
	Diameter (mm):		300	
	Material:		CSP	
	Length (m):		7.0	
	Mitered:		n/a	
	Projection Length (m):			
	US:	n/a	DS:	2.5
	Invert (m):			
US:	no shot	DS:	348.53	
Top of Rail Bed (m):		349.79		
Cover (m):		0.56		
Rail Bed Condition:		Fair - Erosion		
Pipe Condition:		Poor Significant exterior corrosion - some spots corroded through		
Inlet:		Submerged under mud, not found		
Outlet:		Submerged under water (Mara Lake), end is deformed (smashed by lake debris)		
Headwall:	US:	n/a		
	DS:	n/a		
Rip Rap:	US:	n/a	DS:	n/a
Trash Rack:		n/a		
STREAM:				
Flow Type/Source:		Ditch flow - draining towards Mara Lake		
Water Depth (m):	Lake	Water Level Width (m):	Lake	Freeboard (m): 0.80
High Water:	Yes	Scour:	Yes	Debris: Yes
Aggradation: Yes				
COMMENTS:				
Erosion of rail bed on lake side (see photo above) - part of rail bed has disappeared and downstream end of culvert is exposed, high water at lake, no water at upstream end

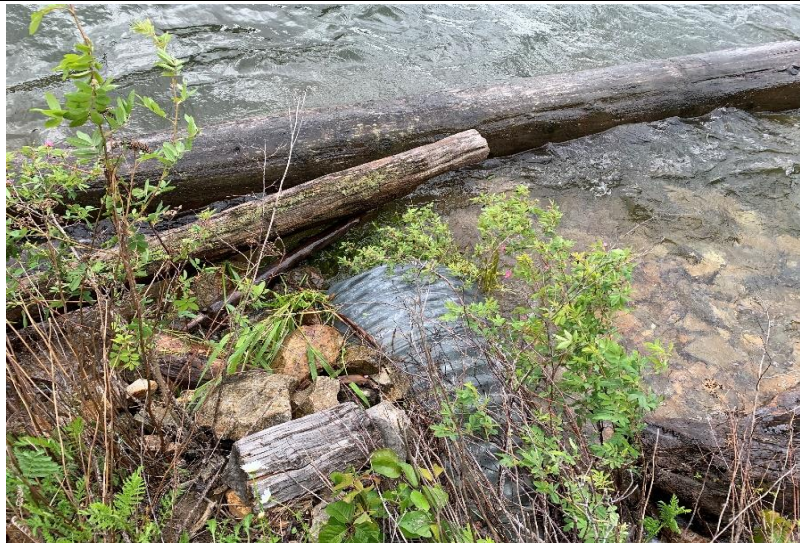
Date Inspected:		June 8, 2020	
		WWAL ID:		n/a	
		CULVERT:			
		Diameter (mm):		600	
		Material:		CSP	
		Length (m):		8.0	
		Mitered:		n/a	
		Projection Length (m):			
		US:	n/a	DS:	1.0
		Invert (m):			
US:	no shot	DS:	348.56		
Top of Rail Bed (m):		349.64			
Cover (m):		0.49			
Rail Bed Condition:		Fair - Erosion			
Pipe Condition:		Excellent Based on culvert exterior observations, unable to observe interior of culvert			
Inlet:		Plugged with mud, not found			
Outlet:		Submerged 75% under lake water (Mara Lake)			
Headwall:	US:	n/a			
	DS:	n/a			
Rip Rap:	US:	n/a	DS:	n/a	
Trash Rack:		n/a			
STREAM:					
Flow Type/Source:		Ditch flow - draining towards Mara Lake			
Water Depth (m):		Lake	Water Level Width (m):		Lake
High Water:		Yes	Scour:	Yes	Debris:
				Yes	Aggradation:
					Yes
COMMENTS:					
Some erosion/scour around culvert on lake side (Mara Lake), high water at lake, no water at upstream end, debris upstreams

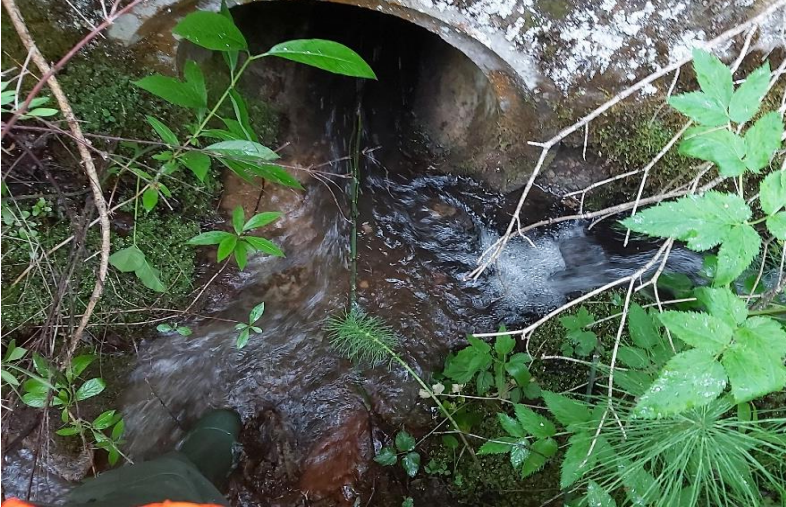
Date Inspected:		June 8, 2020	
		WWAL ID:		n/a	
		CULVERT:			
		Diameter (mm):		600	
		Material:		Concrete	
		Length (m):		10.0	
		Mitered:		n/a	
		Projection Length (m):			
		US:	n/a	DS:	n/a
		Invert (m):			
US:	350.37	DS:	348.67		
Top of Rail Bed (m):		351.12			
Cover (m):		1.00			
Rail Bed Condition:		Good			
Pipe Condition:		Good			
Inlet:		Good condition - No rocks and debris			
Outlet:		Submerged 30% under lake water (Mara Lake)			
Headwall:	US:	Concrete headwall - some concrete has chipped off (minor)			
	DS:	Concrete headwall - at lake			
Rip Rap:	US:	n/a	DS:	n/a	
Trash Rack:		n/a			
STREAM:					
Flow Type/Source:		Ditch flow - draining towards Mara Lake			
Water Depth (m):		0.08	Water Level Width (m):		0.70
Freeboard (m):		0.67			
High Water:	Yes	Scour:	No	Debris:	No
Aggradation:		No			
COMMENTS:					
Discolouration/possible high water mark about halfway up in culvert, high water at lake, some floating debris on lake at outlet

REPAIR:					
Repair Priority:		Low			
Repair/Action Item:		None

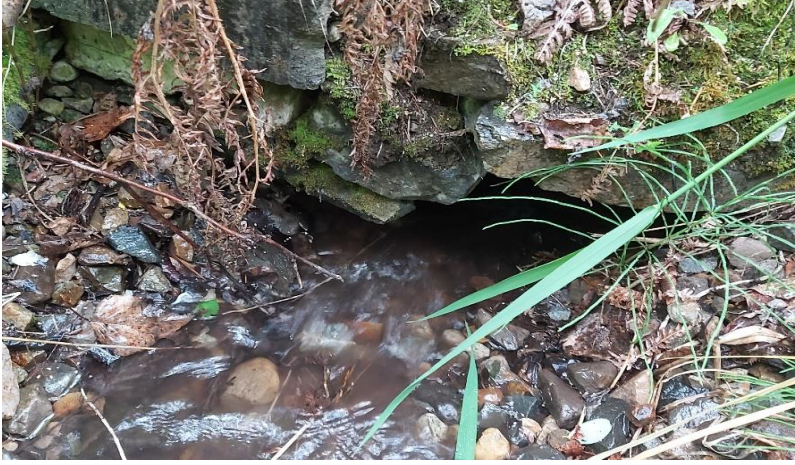
Date Inspected:		June 8, 2020	
		WWAL ID:		Culvert #3	
		CULVERT:			
		Diameter (mm):		400	
		Material:		CSP	
		Length (m):		6.0	
		Mitered:		n/a	
		Projection Length (m):			
		US:	n/a	DS:	n/a
		Invert (m):			
US:	351.08	DS:	no shot		
Top of Rail Bed (m):		352.23			
Cover (m):		0.75			
Rail Bed Condition:		Good			
Pipe Condition:		Poor Deformed, filled 50% with rocks			
Inlet:		Deformed 20%, filled 50% with rocks			
Outlet:		Not observed, unsafe slope			
Headwall:	US:	Rocks utilized as headwall			
	DS:	Not observed, unsafe slope			
Rip Rap:	US:	n/a	DS:	n/a	
Trash Rack:		n/a			
STREAM:					
Flow Type/Source:		Ditch flow - draining towards Mara Lake			
Water Depth (m):		0.05	Water Level Width (m):		0.50
Freeboard (m):		0.90			
High Water:	No	Scour:	No	Debris:	No
Aggradation:		Yes			
COMMENTS:					
REPAIR:					
Repair Priority:		High			
Repair/Action Item:		Replace - end deformed and filled with rocks, clean out ditch and culvert inlet

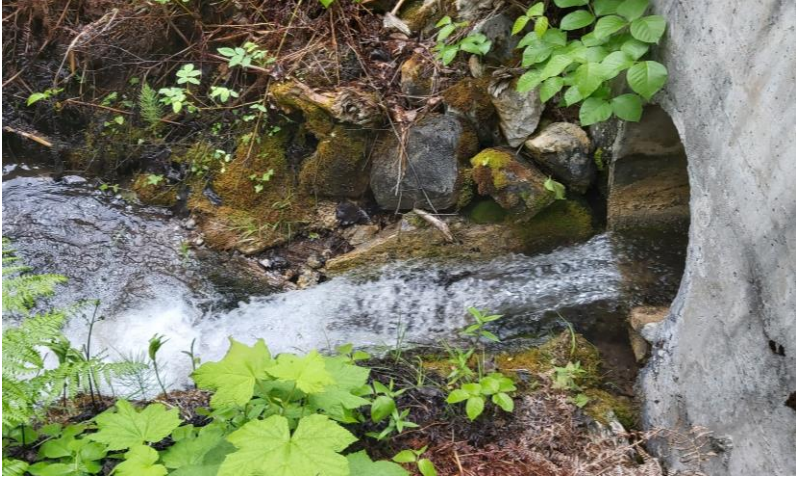
Date Inspected:		June 8, 2020	
		WWAL ID:		Culvert #5	
		CULVERT:			
		Diameter (mm):		600	
		Material:		Concrete	
		Length (m):		10.0	
		Mitered:		n/a	
		Projection Length (m):			
		US:	n/a	DS:	n/a
		Invert (m):			
US:	351.61	DS:	349.69		
Top of Rail Bed (m):		352.32			
Cover (m):		1.07			
Rail Bed Condition:		Good			
Pipe Condition:		Poor Concrete segment has detached, cave-in at detached segment			
Inlet:		Pipe recessed from headwall, some rocks			
Outlet:		Water dropping into scour pool			
Headwall:	US:	Concrete headwall - some rocks, headwall seems to be toppling			
	DS:	Concrete headwall			
Rip Rap:	US:	n/a	DS:	n/a	
Trash Rack:		n/a			
STREAM:					
Flow Type/Source:		Ditch flow - draining towards Mara Lake			
Water Depth (m):		0.10	Water Level Width (m):		0.60
Freeboard (m):		0.61			
High Water:	No	Scour:	Yes	Debris:	No
Aggradation:		Yes			
COMMENTS:					
Due to the detached segment, the embedment material around the culvert may be eroded away and the culvert is possibly undermined, some minor aggradation in inlet

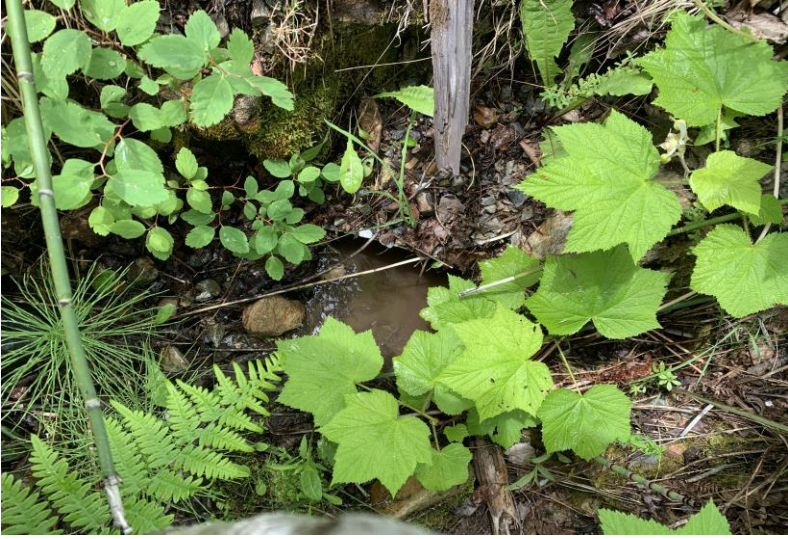
Date Inspected:		June 8, 2020	
		WWAL ID:		n/a	
		CULVERT:			
		Diameter (mm):		300	
		Material:		CSP	
		Length (m):		6.0	
		Mitered:		n/a	
		Projection Length (m):			
		US:	n/a	DS:	n/a
		Invert (m):			
US:	351.66	DS:	351.24		
Top of Rail Bed (m):		352.33			
Cover (m):		0.59			
Rail Bed Condition:		Good			
Pipe Condition:		Fair Filled 50% with sediments, visible interior of culvert is in good condition			
Inlet:		Filled 75% with sediments, rocks and debris			
Outlet:		Filled 50% with sediments, rocks and debris			
Headwall:	US:	n/a			
	DS:	n/a			
Rip Rap:	US:	n/a	DS:	n/a	
Trash Rack:		n/a			
STREAM:					
Flow Type/Source:		Ditch flow - draining towards Mara Lake			
Water Depth (m):		0.05	Water Level Width (m):		0.40
High Water:	No	Scour:	No	Debris:	Yes
		Aggradation:	Yes		
COMMENTS:					
Upstreams of inlet sediments and debris have built up causing a waterfall effect into culvert					
REPAIR:					
Repair Priority:		High

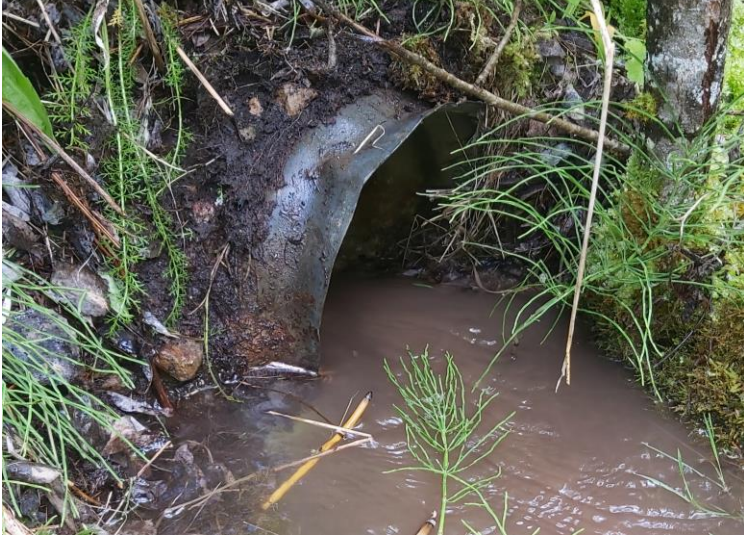
Date Inspected:		June 8, 2020	
		WWAL ID:		Culvert #7	
		CULVERT:			
		Diameter (mm):		300	
		Material:		CSP	
		Length (m):		9.0	
		Mitered:		n/a	
		Projection Length (m):			
		US:	n/a	DS:	2.0
		Invert (m):			
US:	351.44	DS:	350.73		
Top of Rail Bed (m):		352.06			
Cover (m):		0.68			
Rail Bed Condition:		Good			
Pipe Condition:		Fair Visible corrosion on culvert floor and sidewalls			
Inlet:		Some debris at inlet			
Outlet:		Situated above ground, water is dropping onto rocks below - about 1 metre drop			
Headwall:	US:	n/a			
	DS:	n/a			
Rip Rap:	US:	n/a	DS:	n/a	
Trash Rack:		n/a			
STREAM:					
Flow Type/Source:		Ditch flow - draining towards Mara Lake			
Water Depth (m):		0.12	Water Level Width (m):		0.70
High Water:		No	Scour:	Yes	Debris: Yes
				Aggradation:	No
COMMENTS:					
Some scouring downstream of culvert due to water dropping from culvert					
REPAIR:					
Repair Priority:		Medium			
Repair/Action Item:		Replace - corrosion

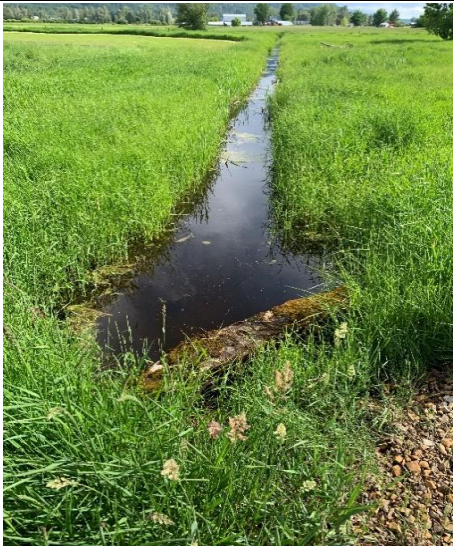
Date Inspected:		June 8, 2020	
	WWAL ID:		Culvert #8	
	CULVERT:			
	Diameter (mm):		Not determined	
	Material:		Not determined	
	Length (m):		8.0	
	Mitered:		n/a	
	Projection Length (m):			
	US:	n/a	DS:	n/a
	Obvert (m):			
US:	348.62	DS:	348.52	
Top of Rail Bed (m):		349.78		
Cover (m):		1.21		
Rail Bed Condition:		Good		
Pipe Condition:		Not determined Fully submerged pipe. Water level = 348.97 (±0.4m above obvert).		
Inlet:		Not determined, submerged.		
Outlet:		Not determined, submerged		
Headwall:	US:	Concrete headwall - fair condition, 1913 concrete imprint.		
	DS:	Concrete headwall - fair condition, 1913 concrete imprint.		
Rip Rap:	US:	n/a	DS:	n/a
Trash Rack:		n/a		
STREAM:				
Flow Type/Source:		Stream cutting through pastures - draining towards Rosemond Lake		
Water Depth (m):	1.08	Water Level Width (m):	2.00	Freeboard (m): 0.81
High Water:	Yes	Scour:	No	Aggradation: No
COMMENTS:				
Pipe is submerged, condition could not be assessed.

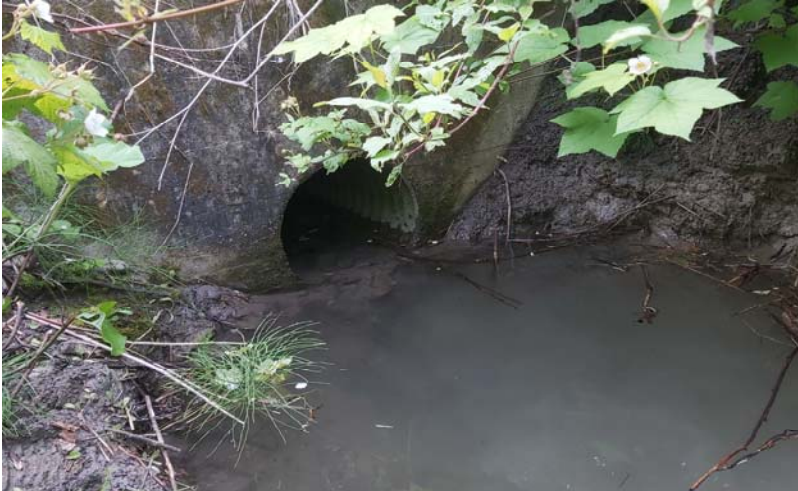
Date Inspected:		June 9, 2020		
		WWAL ID:		n/a		
		CULVERT:				
		Diameter (mm):		450		
		Material:		CSP		
		Length (m):		8.0		
		Mitered:		n/a		
		Projection Length (m):				
		US:		n/a	DS:	n/a
		Invert (m):				
US:		349.35	DS:	349.02		
Top of Rail Bed (m):		350.92				
Cover (m):		1.29				
Rail Bed Condition:		Good				
Pipe Condition:		Good Corrossion visible on floor.				
Inlet:		Some rocks and sediments.				
Outlet:		Submerged, some rocks and sediment.				
Headwall:	US:	Concrete headwall				
	DS:	Concrete headwall				
Rip Rap:	US:	n/a	DS:	n/a		
Trash Rack:		n/a				
STREAM:						
Flow Type/Source:		Ditch flow - draining towards the Shuswap River (standing water June 09)				
Water Depth (m):		0.45	Water Level Width (m):		1.40	
Freeboard (m):		1.46				
High Water:	No	Scour:	No	Debris:	No	
Aggradation:		Yes				
COMMENTS:						
Farmer excavated deep pools at upstream and downtown ends.						
REPAIR:						
Repair Priority:		Medium

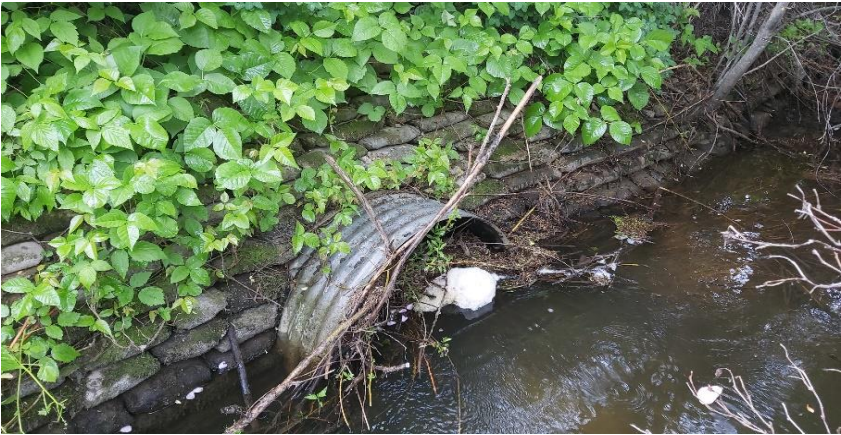
Date Inspected:		June 9, 2020	
		WWAL ID:		Culvert #9	
		CULVERT:			
		Diameter (mm):		1000	
		Material:		CSP	
		Length (m):		20.0	
		Mitered:		n/a	
		Projection Length (m):			
		US:	0.2	DS:	0.5
		Invert (m):			
US:	351.70	DS:	351.24		
Top of Rail Bed (m):		354.86			
Cover (m):		2.39			
Rail Bed Condition:		Good			
Pipe Condition:		Fair Partly submerged, debris buildup and blockage			
Inlet:		60% submerged, 75% debris buildup and blockage, small pool			
Outlet:		95% submerged, large deep pool			
Headwall:	US:	Rocks utilized as headwall			
	DS:	n/a			
Rip Rap:	US:	n/a	DS:	n/a	
Trash Rack:		n/a			
STREAM:					
Flow Type/Source:		Stream flow - draining towards the Shuswap River			
Water Depth (m):	0.50	Water Level Width (m):	2.00	Freeboard (m):	2.56
High Water:	Yes	Scour:	No	Debris:	Yes
Aggradation:		Yes			
COMMENTS:					
Downstream pool very deep, unsafe to enter.					
REPAIR:					
Repair Priority:		Medium			
Repair/Action Item:		Clean out debris and sediment.

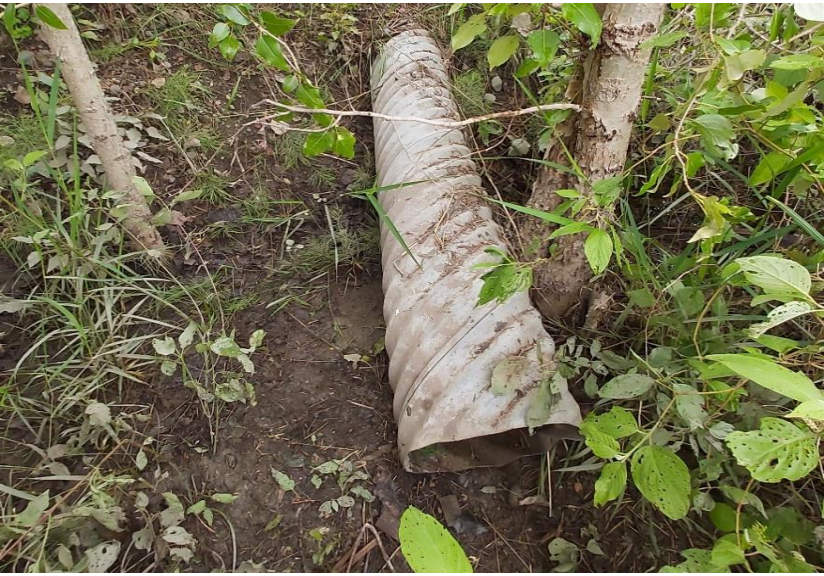
Date Inspected:		June 10, 2020	
		WWAL ID:		n/a	
		CULVERT:			
		Diameter (mm):		300	
		Material:		CSP	
		Length (m):		27.0	
		Mitered:		n/a	
		Projection Length (m):			
		US:	n/a	DS:	1.9
		Invert (m):			
US:	353.31	DS:	351.61		
Top of Rail Bed (m):		355.43			
Cover (m):		2.22			
Rail Bed Condition:		Good			
Pipe Condition:		Poor Very minor corrosion, ends damaged - reducing capacity			
Inlet:		Culvert end is corroded, cracked and collapsed			
Outlet:		Culvert end is squished - 50% capacity.			
Headwall:	US:	n/a			
	DS:	n/a			
Rip Rap:	US:	n/a	DS:	n/a	
Trash Rack:		n/a			
STREAM:					
Flow Type/Source:		Ditch flow - draining towards Fortune Creek			
Water Depth (m):	0.00	Water Level Width (m):		Creek DS	Freeboard (m): 2.12
High Water:	Yes	Scour:	No	Debris:	No
Aggradation: No					
COMMENTS:					
Downstream culvert end located close to Fortune Creek - about 2m from creek (high water level at time of inspection). Currently no flow through culvert, upstream ditch is dry.

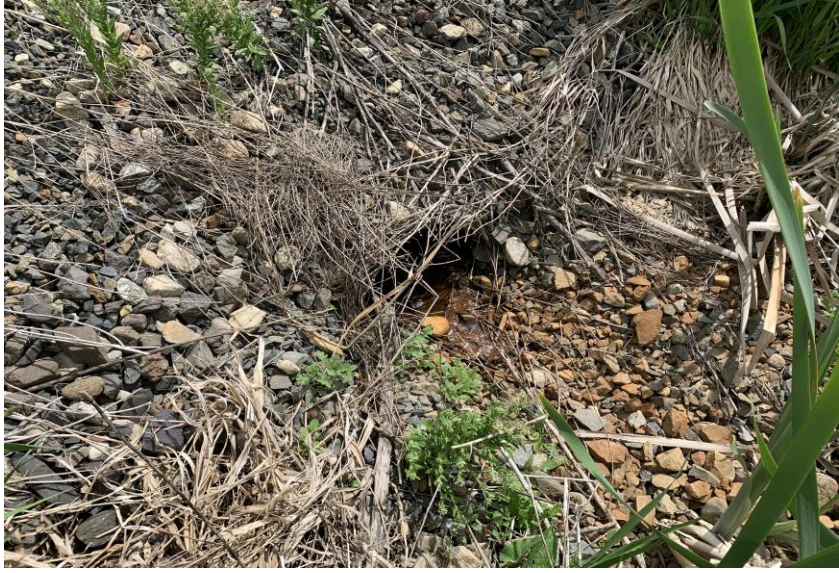
Date Inspected:		June 10, 2020			
		WWAL ID:		n/a			
		CULVERT:					
		Diameter (mm):		400			
		Material:		CSP			
		Length (m):		6.0			
		Mitered:		n/a			
		Projection Length (m):					
		US:		n/a	DS:		n/a
		Invert (m):					
US:		352.03	DS:		352.10		
Top of Rail Bed (m):				352.94			
Cover (m):				0.48			
Rail Bed Condition:				Good			
Pipe Condition:		Poor Severely corroded floor and sidewalls, filled 35-50% with rocks, negative slope (downstream is at a higher elevation than upstreams)					
Inlet:		Filled 35% with rocks, submerged 50% under standing water					
Outlet:		Filled 50% with rocks					
Headwall:	US:	n/a					
	DS:	n/a					
Rip Rap:	US:	n/a	DS:	n/a			
Trash Rack:		n/a					
STREAM:							
Flow Type/Source:		Ditch flow - draining towards Fortune Creek					
Water Depth (m):	0.00	Water Level Width (m):		2.00	Freeboard (m):	0.70	
High Water:	No	Scour:	No	Debris:	Some	Aggradation:	Yes
COMMENTS:							
Standing water upstreams, no water downstream

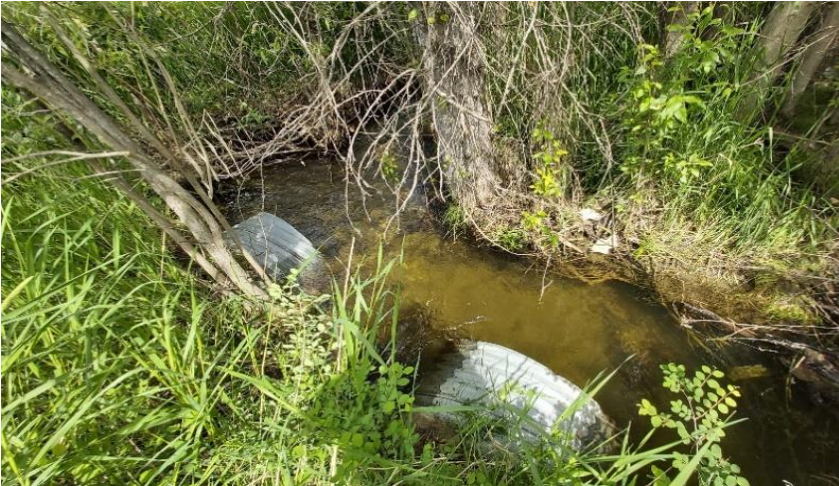
Date Inspected:		June 10, 2020		
		WWAL ID:		n/a		
		CULVERT:				
		Diameter (mm):		2-1200		
		Material:		CSP		
		Length (m):		10.0		
		Mitered:		n/a		
		Projection Length (m):				
		US:		0.5	DS:	n/a
		Invert (m):				
US:		353.94	DS:	353.76		
Top of Rail Bed (m):		355.95				
Cover (m):		0.90				
Rail Bed Condition:		Good				
Pipe Condition:		Poor Significant sediments within culvert, over 90% submerged, visible exterior corrosion, internal assessment of culvert could not be completed due to the culvert being submerged				
Inlet:		65% filled with sediments, 95% submerged				
Outlet:		65-75% filled with sediments, 100% submerged				
Headwall:	US:	Erosion undermining headwall				
	DS:	n/a				
Rip Rap:	US:	n/a	DS:	n/a		
Trash Rack:		n/a				
STREAM:						
Flow Type/Source:		Stream flow - draining towards Fortune Creek				
Water Depth (m):	see blw.	Water Level Width (m):	2.50	Freeboard (m):	1.02	
High Water:	Yes	Scour:	Yes	Debris:	No

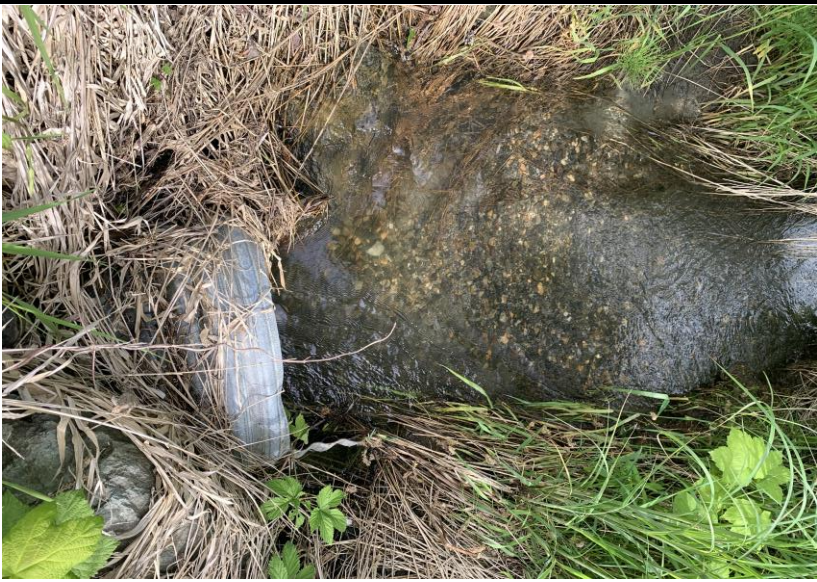
Date Inspected:		June 10, 2020			
		WWAL ID:		n/a			
		CULVERT:					
		Diameter (mm):		600			
		Material:		CSP			
		Length (m):		12.0			
		Mitered:		Yes			
		Projection Length (m):					
		US:		n/a	DS:		n/a
		Invert (m):					
US:		356.75	DS:		356.67		
Top of Rail Bed (m):		357.45					
Cover (m):		0.14					
Rail Bed Condition:		Good					
Pipe Condition:		Poor Corrosion, sediments, partly submerged					
Inlet:		Some sediments, scouring, 40% submerged					
Outlet:		Sediments, 100% submerged					
Headwall:	US:	n/a					
	DS:	n/a					
Rip Rap:	US:	n/a	DS:	n/a			
Trash Rack:		n/a					
STREAM:							
Flow Type/Source:		Stream flow - draining towards Fortune Creek					
Water Depth (m):	see blw.	Water Level Width (m):		1.00	Freeboard (m):	1.01	
High Water:	Yes	Scour:	Yes	Debris:	No	Aggradation:	Yes
COMMENTS:							
Water Depth (m): US = 0.2 DS = 0.7 Culvert partially plugged or collapsed							
REPAIR:							
Repair Priority:		High
