FROM:	April Creighton, P Eng Bourcet Engineering	DATE:	May 5, 2021
		FILE:	19-383
ATTENTION:	Phil McIntyre, Shuswap Trail Alliance & Thomas Simkins, Urban Systems Ltd.	EMAIL:	<a href="mailto:phil@shuswaptrails.com">phil@shuswaptrails.com</a> <a href="mailto:tsimkins@urbansystems.ca">tsimkins@urbansystems.ca</a>

# CSRD RAIL TRAIL BRIDGE ASSESSMENT

June 11 2021

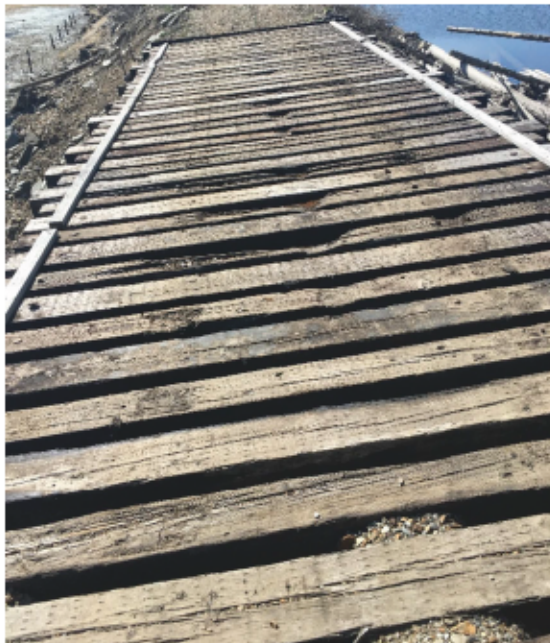
1. Deck Ties- 9"x7½" creosote treated ties and 7"x7" treated ties with a bottom plywood shim @ overall 1'-0" c/c spacing. {Figure 2.2.1}
  - a. 40'-8" long surface with 43 deck ties in total.
  - b. 12'-0" long ties with about 9" overhang (of the rail ties over the beam support).
  - c. Deterioration and rot observed on 20-22 of the ties as indicated in Figure 2.2.2.

FIGURE 2.2.2-DETERIORATED DECK TIES

The majority of the existing deck ties require replacement. Improving the deck surface by removing tripping hazards, large gaps or openings between members to ensuring serviceability by multiple users (people, bikes, horses and other pets etc) is one of the required safety upgrades. The remediation work and surface safety upgrades should be completed simultaneously. BE recommends replacing all the deck ties with new treated solid 6"x6" Douglas-fir #2 or better ties @ 3'-0" c/c spacing. The new deck ties should be secured to the main beams using [1] 3/8" diameter GRK RSS galvanized structural screw per beam ply, to a maximum of 6 per tie. The bridge surface should be solid decking running perpendicular to the deck ties (in line with the path direction). Use treated, 1 1/2" thick D-fir decking, secured using [2] 3/8" diameter GRK RSS galvanized structural screws per support. The finish of the surface material, milled or rough or stained etc., is at the discretion of the CSRD and STR.

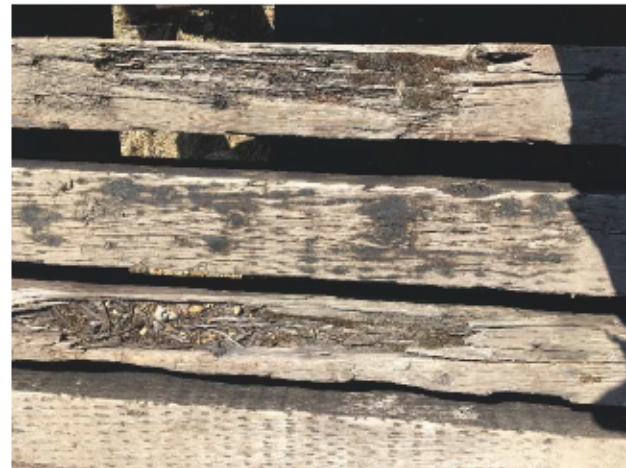
FIGURE 2.2.1-DECK TIES AND DETERIORATION

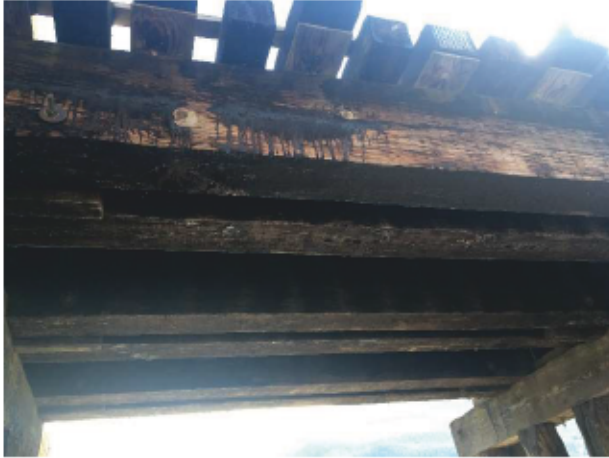
FIGURE 2.2.3- MAIN BEAMS

2. Main Beams (3 total)- [2] ply 9½"x19½" solid treated timbers approximately 6" apart. {Figure 2.2.3}
  - a. Maximum spacing of 2'-1" between main beam lines.
  - b. Maximum span 15'-2" and minimum span 11'-9".
  - c. Overall beam condition is good. A drip cap over the beams helped to preserve the beam conditions.
  - d. Beam spacer/anchor at each bearing line where [2] ¾" diameter thru bolts are located; refer to Figure 2.2.3 and Figure 2.2.4.
3. Secondary Beams (4 total)- 16"x12" creosote treated solid timbers. {Figure 2.2.5 & Figure 2.2.6}
  - a. Typical beam length of 16'-0" with an average 1'-4" overhang from pile ends.
  - b. Overall beam condition is good with no visible deterioration or rot observed.
  - c. Spacers from main beam notched at secondary beam locations to provide top saddle for stability of secondary beam. {Figure 2.2.4}

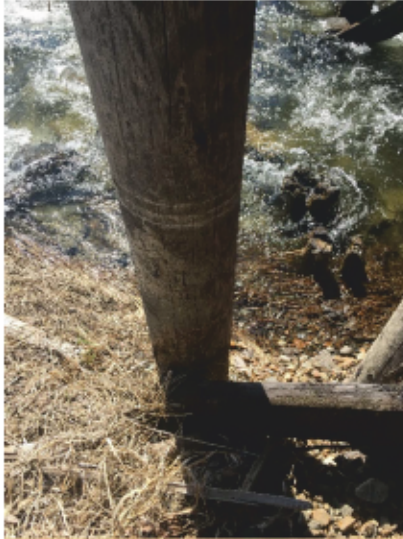
FIGURE 2.2.7- PILES

4. Piles-average 12" diameter creosote treated piles. {Figure 2.2.7}
  - a. Embedded into the earth or water at unknown depths.
  - b. All the piles have a vertical alignment. {Figure 2.2.8}
  - c. There are 4 bearing lines with either 5 or 6 piles per bearing line.
  - d. Pile heights vary as grade varies with a maximum visible height of 9'-0".
  - e. Overall pile condition is good with signs of previous remediation work. The remediation work consisted of replacing sections of piles with treated 11½"x11½"x25" deep (average) treated members as shown in Figure 2.2.9.
  - f. There were signs of abandoned piles near the bearing line 11'-9" from abutment B. There were assumed to have been from a previous bearing line that was moved/replaced by CPR prior to the decommissioning of the line. {Figure 2.2.8}

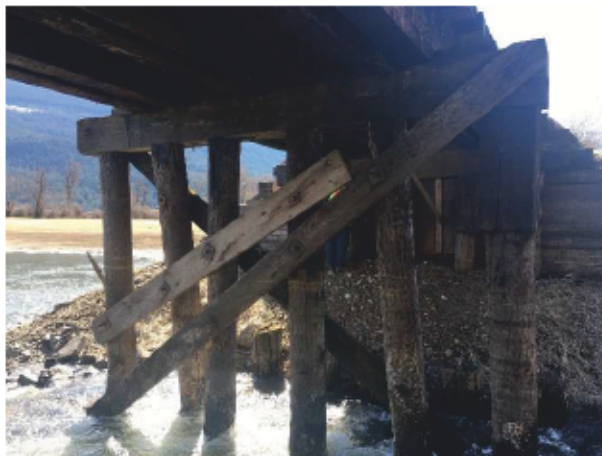
FIGURE 2.2.10-CROSS BRACING "X"

- a. Cross bracing observed on interior bearing lines only.
- b. Typically, 1 brace per side in opposite orientation to create an "X" as shown in Figure 2.2.10. Some had multiple brace members per side
- c. Braces anchored with  $\frac{3}{4}$ " diameter thru bolts and large washers to piles similar to other connections. {Figure 2.2.11}

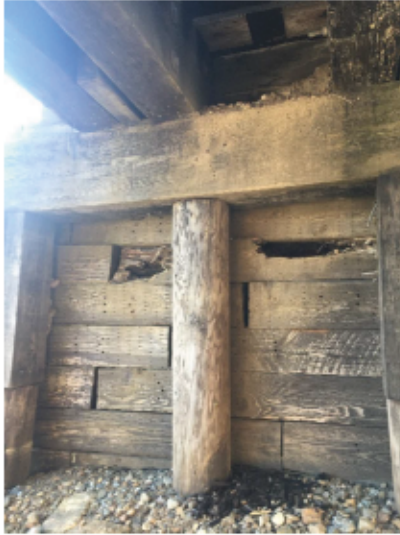
FIGURE 2.2.12-ABUTMENT A

- a. Overall the abutments for this bridge were in poor condition.
- b. Abutment A (Grid Line 1 in Figure 2.1.3) about 8'-0" or 8 visible courses high. This abutment had multiple locations of deterioration, rot and fatigue throughout. {Figure 2.2.12 and 2.2.13}
- c. A section of abutment A had been previously remediated and was supported by plywood, and a brace back to the main bridge beam. {Figure 2.2.14}
- d. Abutment B (Grid Line 4 Figure 2.1.3) about 5'-0" or 5 visible courses high. This abutment showed signs of fatigue [Figure 2.2.15].

Both existing abutments show signs of fatigue and deterioration with abutment A having previous remediation work visible. BE recommends replacing both abutments with a similar treated built-up abutment. Ideally, excavate from the back and replace the existing railway ties with 6"x12" solid timber treated members. 3/4" diameter rods should be inserted vertically through the solid members @ 16" c/c. The buried configuration (including tie backs etc) and depth of the abutments is unknown but, is assumed to be in a similar condition to the visible portions and will require replacement. The length and height of the new abutments should match the existing where possible and is dictated by the site conditions/grade.

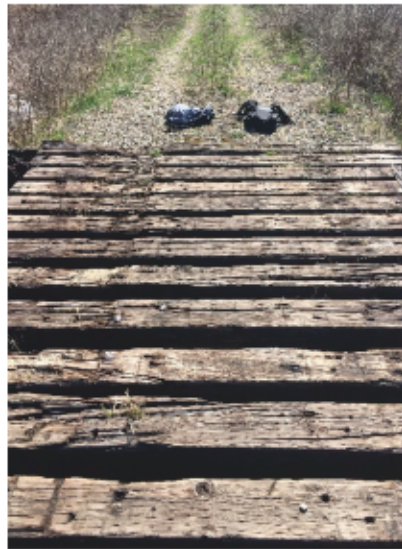
1. Deck Ties- 7½"x7½" creosote treated deck ties @ 1'-0" c/c spacing. {Figure 3.2.1}
  - a. Deck is 44'-8" long with 46 deck ties in total.
  - b. Existing surface is 10'-0" wide with each rail tie having about a 10" overhang on both sides.
  - c. Deterioration and rot observed in the ties as indicated in Figure 3.2.2. & Figure 3.2.3.

FIGURE 3.2.2-DECK DETERIORATION

The majority of the existing deck ties require replacement. Improving the deck surface is a safety upgrade requirement. The upgrades should remove any tripping hazards, large gaps or openings between members to ensuring serviceability by multiple users (people, bikes, horses and other pets etc) on the bridge surface. The remediation work and surface safety upgrades should be completed simultaneously. BE recommends replacing all the deck ties with treated solid 6"x6" Douglas-fir #2 or better ties @ 3'-0" c/c spacing. The new deck ties should be secured to the main beam with [1] 5/8" diameter GRK RSS galvanized structural screw per beam ply with a maximum of [6] anchors per tie. The new bridge surface is solid treated decking running perpendicular to the deck ties or in line with the trail direction. Use treated, 1 ½" thick D-fir decking, secured using (2) 5/8" diameter GRK RSS galvanized structural screws per support. The finish of the surface material, milled or rough or stained etc., is at the discretion of the CSRD and STR. Refer to the bridge specific drawing files (attachment #2) for clarification on the new deck framing.

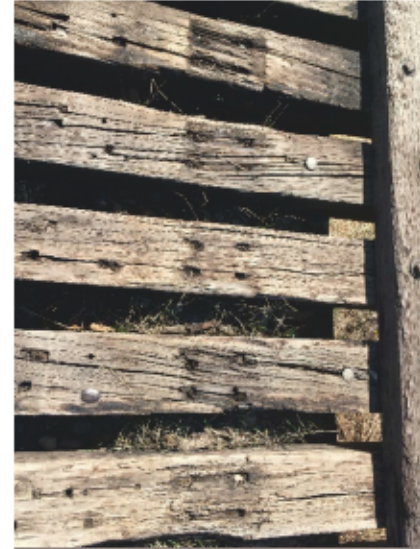
FIGURE 3.2.3-DECK DETERIORATION

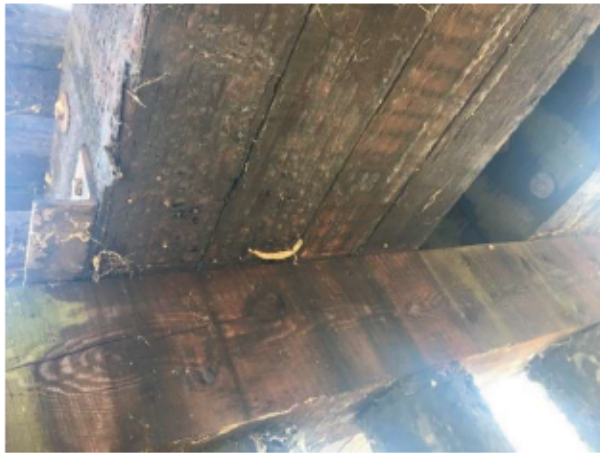
FIGURE 3.2.4- MAIN BEAMS

2. Main Beams (2 total)- [4] ply 9½"x17½" built up creosote treated timbers. {Figure 3.2.4 & 3.2.5}
  - a. Maximum interior spacing of 2'-0" between beams.
  - b. Maximum span 15'-6" and minimum span 14'-0".
  - c. Overall beam condition is good.
  - d. Beam are anchored to secondary beams with 6"x4" angle iron connections.
  - e. The built-up beams are anchored together with ¾" diameter thru bolts along their span. {Figure 3.2.7}
3. Secondary Beams (4 total)- 14"x14" creosote treated solid timber beams. {Figure 3.2.5 & 3.2.6}
  - a. Beam lengths vary between 14'-0" and 12'-6" with a typical pile overhangs of 16" (from piles on ends).
  - b. Overall beam condition is moderate with some green mildew and moss observed, refer to figure 3.2.8 near abutment A.
  - c. 6"x4" angle iron connections are used to anchor the main beam and secondary beams. {Figure 3.2.7}

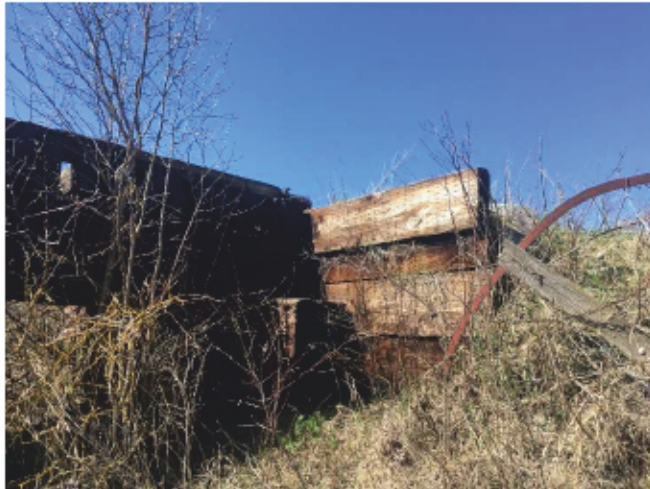
FIGURE 3.2.16- ABUTMENT B

6. Abutments-12" deep creosote treated built up members.
  - a. Overall the abutments for this bridge were in moderate to poor condition.
  - b. Abutment A (Grid Line 1 in Figure 3.1.3) is about 5'-0" or 5 visible courses high. This abutment showed signs of fatigue and deterioration. {Figure 3.2.14 and 3.2.15}
  - c. Abutment B (Grid Line 4 Figure 2.1.3) about 3'-0" or 3 visible courses high. This abutment showed signs of fatigue. {Figure 2.2.16}

Both existing abutments show signs of fatigue and deterioration. BE recommends replacing the abutments with similar treated built-up abutments. Excavate from the back and replace the existing railway ties with 6"x12" solid timber treated members. ¾" diameter rods should be installed vertically through the solid members @ 16"c/c. The buried configuration, such as tie backs etc, and depth of the abutments is unknown but, is assumed to be in similar condition to the visible portions and will require replacement. The length and height of the new abutments should match the existing where possible and accommodate the site conditions/grade. Refer to the bridge upgrade drawings file (attachment #2) for clarification on the design.

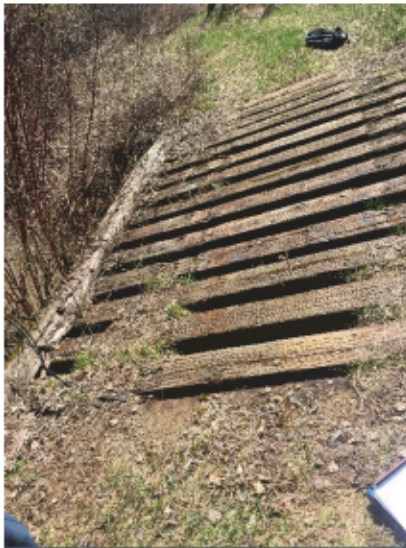
FIGURE 4.2.1-DECK TIES

1. Deck Ties- 7½"x7½" creosote treated deck ties @ 1'-0" c/c spacing. {Figure 4.2.1 & 4.2.2}
  - a. Surface is 15'-6" long with about 15 deck ties in total.
  - b. Typically, a 1'-4" overhang was measured for the ties over the main beams.
  - c. The surface width is 10'-0"
  - d. Deterioration, rot and age were observed in the majority of the ties. {Figure 4.2. & 4.2.3}

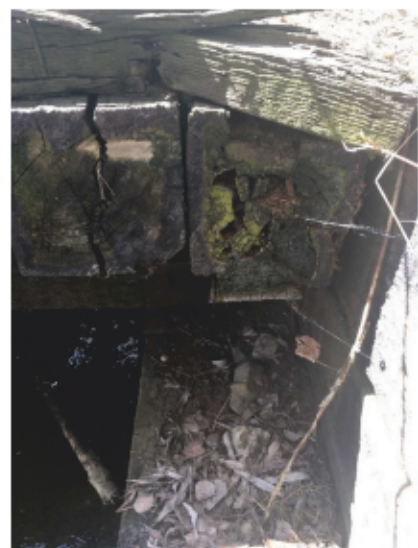
FIGURE 4.2.3-DECK TIE DETERIORATION

The majority of the existing deck ties require replacement. Improving the deck surface is a safety upgrade requirement. The upgrades should remove any tripping hazards, large gaps or openings between members to ensuring serviceability by multiple users (people, bikes, horses and other pets etc.). It is recommended that the remediation work and surface safety upgrades should be completed together. BE recommends replacing all the deck ties with treated solid 6"x6" Douglas-fir #2 or better ties @ 3'-0" c/c spacing. The new deck ties should be secured to the main beam using [1] 5/8" diameter GRK RSS galvanized structural screws per beam ply with a total of [6] anchors per tie. The new bridge surface, running perpendicular to the deck ties or in line with the path direction, should be 1 1/2" thick treated D-fir decking. The decking should be secured with (2) 5/8" diameter GRK RSS galvanized structural screws per support. The finish of the surface material is at the discretion of the CSRD and STR. Refer to the bridge specific drawing files (attachment 2) for clarification on the new deck framing.

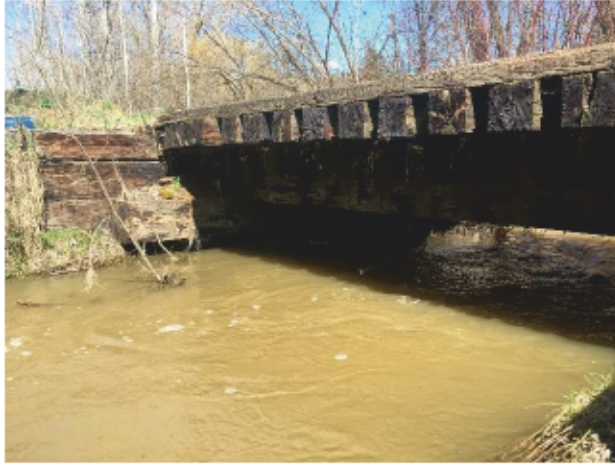
FIGURE 4.2.4-MAIN BEAM-LOOKING NORTH

2. Main Beams (2 total)- 2'-4"x17½" creosote treated timber beams (built-up). {Figure 4.2.4 & 4.2.5}
  - a. Maximum interior spacing of 2'-8" between the beams (measured from the top).
  - b. The beams have a span of 15'-6".
  - c. The beams appeared to be built-up, but the width of each ply was hard to confirm from the surface. Visibility was obscured by dirt and debris that had fallen between the ties.
  - d. Overall beam condition is moderate. With visible green mildew along their sides. {Figure 4.2.6}
  - e. Beam are anchored to secondary beams with 6"x4" angle iron connections.
  - f. The built-up beams are anchored together with ¾" diameter thru bolts along their span. {Figure 4.2.7}

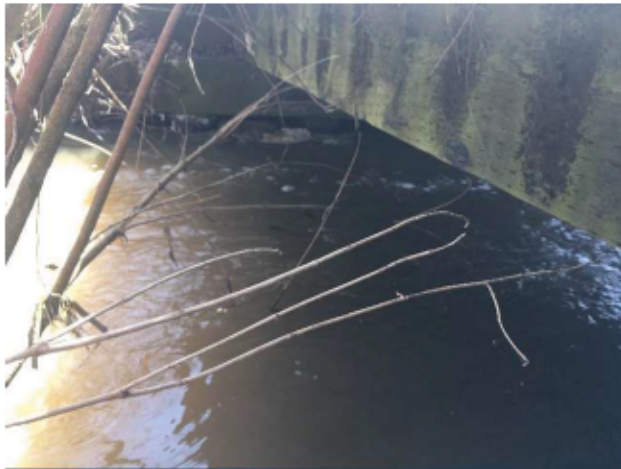
FIGURE 4.2.6-MAIN BEAM MILDEW

Most of the visible support members contained mildew or moss on their surface. Mildew and moss as previously described, can contribute to damage and deterioration of the members. During BE's site visit, the mildew appeared to only effect the surface of the members. BE recommends removing all the mold and mildew from all structure surfaces and annual maintenance performed to prevent future growth on the bridge structure.

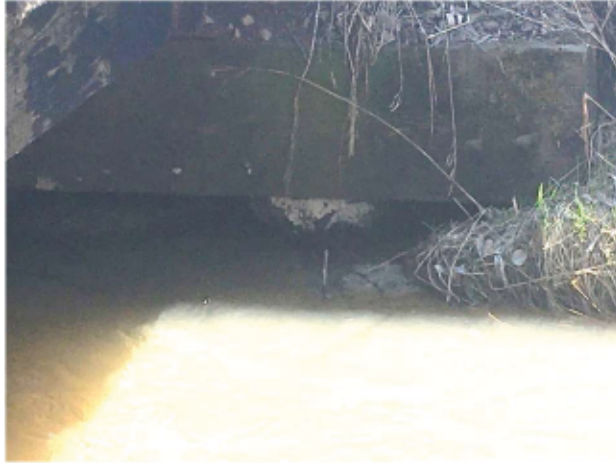
4. Secondary Beams (2 total)- 14"x14" creosote treated solid timber beams. {Figure 4.2.8 & 4.2.9}
  - a. Beam lengths are approximately 10'-0" and have a pile overhang (from piles on ends).
  - b. Overall beam condition appeared to be moderate with green mildew observed.
  - c. 6"x4" angle iron connections used to anchor main beam and secondary beam. {Figure 4.2.7}
  - d. Underside visual examination was not possible due to high water levels.
5. Piles-circular treated piles. {Figure 4.2.9 & 4.2.10}
  - a. Existing piles are embedded into the water at unknown depths.
  - b. There are 3 piles per bearing line.
  - c. The piles appeared to have vertical alignment based on the small portion visible.
  - d. At time of inspection, the piles were almost completely submerged. This made confirming their visible condition difficult. {Figure 4.2.9}

FIGURE 4.2.8-SECONDARY BEAM WITH MILDEW

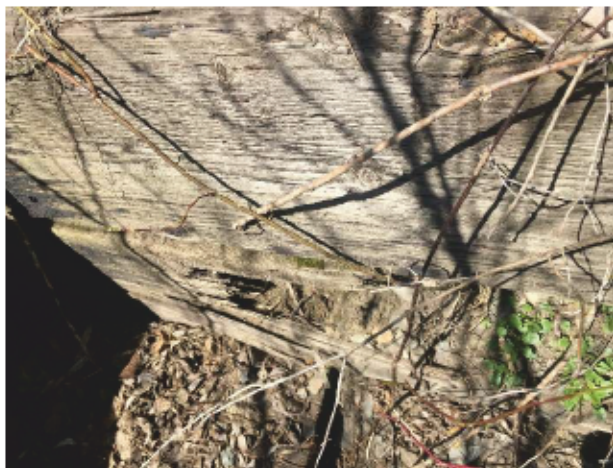
6. Abutments-12" deep creosote treated built up members.
  - a. Overall the abutments for this bridges were in poor condition.
  - b. Abutment A (Grid Line 1 in Figure 3.1.3) about 3'-0" or 3 visible courses high. This abutment showed signs of fatigue.
  - c. Abutment B (Grid Line 2 Figure 3.1.3) about 3'-0" or 3 courses high. This abutment showed signs of fatigue and deterioration. Refer to figure 4.2.11.

FIGURE 4.2.11-ABUTMENT B- DETERIORATION

Both existing abutments show signs of fatigue and/or deterioration. BE recommends replacing both abutments with a similar treated built-up members. Ideally, excavate, from the back, and remove the existing abutments. Replace with 6"x12" solid timber treated members and 3/4" diameter rods inserted vertically through the solid members @ 16"c/c. The buried configuration (tie backs etc) and depth of the abutments is unknown but, is assumed to be in similar condition to the visible portions and will require replacement. The length and height of the new abutments should match the existing where possible and accommodate the site conditions/grade. Refer to the bridge upgrade drawings file (attachment #2) for clarification on the design.

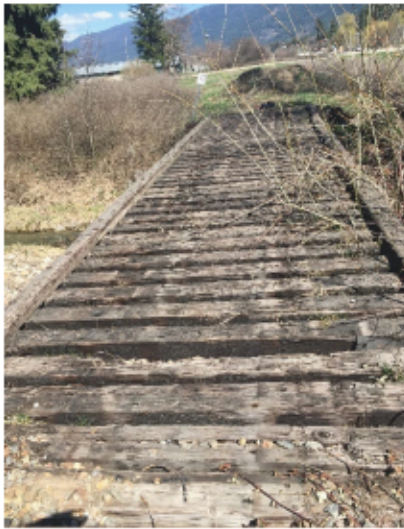
FIGURE 5.2.1-DECK TIES

1. Deck Ties- 7½"x7½" creosote treated deck ties @ 1'-0" c/c spacing. {Figure 5.2.1 & 5.2.2}
  - a. The bridge is 45'-06" long and has about 46 deck ties in total.
  - b. The bridge deck is 10'-0" wide and the ties have a typically overhang of 10" on both sides.
  - c. Deterioration, rot and age were observed in the ties. {Figure 5.2.3}

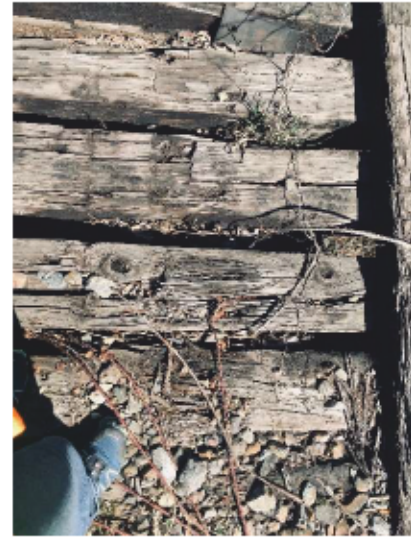
FIGURE 5.2.3-DECK TIE DETERIORATION

The majority of the existing deck ties require replacement. Improving the deck surface is also a safety upgrade requirement. The upgrades should remove any tripping hazards, large gaps or openings between members to ensuring serviceability by multiple users (people, bikes, horses and other pets etc.). The remediation work and surface safety upgrades should be completed simultaneously. BE recommends replacing all the deck ties with treated solid 6"x6" Douglas-fir #2 or better ties @ 3'-0" c/c spacing. The new deck ties should be secured to the main beam using [1]  $\frac{5}{8}$ " diameter GRK RSS galvanized structural screw, per beam ply or to a maximum of 6 per tie. The new bridge surface should be solid 1  $\frac{1}{2}$ " thick Douglas-Fir treated decking. The decking should run perpendicular to the deck ties or in the path direction. Secure the decking

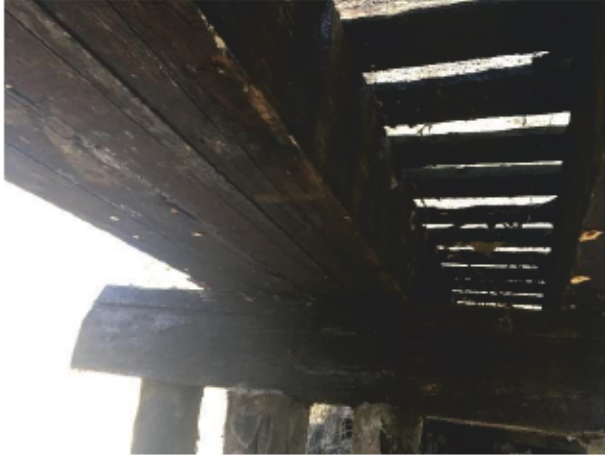
FIGURE 5.2.4-BUILT UP MAIN BEAM

2. Main Beams (2 total)- [4] ply 9"x17½" creosote treated built-up timber beams. {Figure 5.2.4 & 5.2.5}
  - a. The main beams have a maximum interior spacing of 2'-4".
  - b. Their maximum span is 16'-5" and minimum span is 14'-1".
  - c. Overall beam condition is good.
  - d. The beams are anchored together with ¾" diameter thru bolts with large washers along their length.
  - e. The main beam is also anchored to the secondary beam with 6"x4" angle iron connections. {Figure 5.2.6}
3. Secondary Beams (4 total)- 14"x14" creosote treated solid timber beams. {Figure 5.2.7}
  - a. The secondary beams have continuous 14"x4" top plates that the main beams bear on. {Figure 5.2.8}
  - b. Beam lengths vary but average about 11'-6" and have a typical pile overhangs of 1'-0" (from piles on ends).

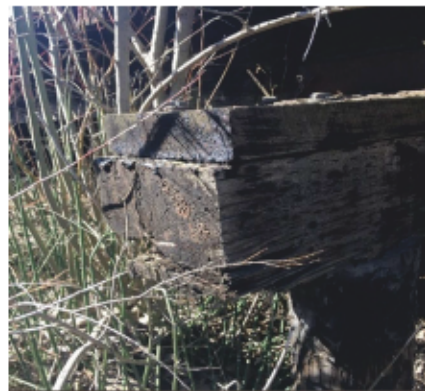
- c. Overall beam condition is moderate except for bearing line 3, as noted on grid line 3- Figure 5.1.3. The south end of the secondary beam show signs of deterioration and rot. {Figure 5.2.9}
- d. 6"x4" angle iron connections are used to anchor the main beam and secondary beam. {Figure 5.2.8}

FIGURE 5.2.9-BEARING LINE 3-SOUTH END-DAMAGE

The secondary beam on bearing line 3, grid line 3, Figure 5.13 and Figure 5.2.9, has documented rot and deterioration on its end. It appeared that the rot only effected the cantilevered beam end. Due to this, BE recommends replacing and/or removing the deteriorated section of the secondary beam. [2] options are provided depending on the extent of the decay and deterioration.

- Temporarily support the bridge structure and cut only the overhanging portion of the beam about 1'-0" (to the end pile edge).
- If no signs of deterioration, damage or rot are visible within the beam; prepare the cut end with treated paint (if required) and the required remediation is completed.
- If damage is still visible at the cut section, the secondary beam will need to be removed and replaced back to the center of the next support pile (The length of replacement is governed by the extend of the damage. When no deterioration is noted within the beam the replacement can stop.
- Replace the removed beam sections with an equivalent sized treated wood member.
- Secure the new beam to the piles with galvanized structural screws inserted at 45-degree angles.

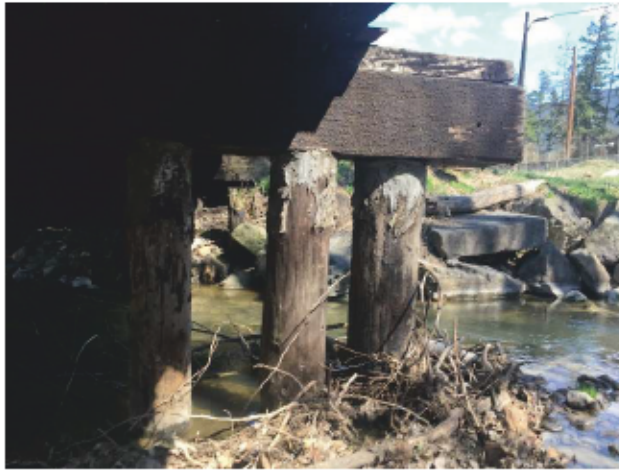
FIGURE 5.2.10-PILES WITH WRAPS

4. Piles-circular treated piles {Figure 5.2.10}
  - a. Embedded into the grade/water at unknown depths.
  - a. The number of pies per bearing line varies between 3 and 7.
  - b. Protective wraps are present on all pile as pile caps. They appear to be in good condition and are still protecting the piles. {Figure 5.2.10}
  - c. Bearing line 2 has a double pile, second from the north end. {Figure 5.2.11}
  - d. The piles are vertically aligned consistently. {Figure 5.2.12}
  - e. Remediation work was previously completed on this bridge. There are cut off piles extruding from the ground near bearing line 1 and 4. {Figure 5.1.3}

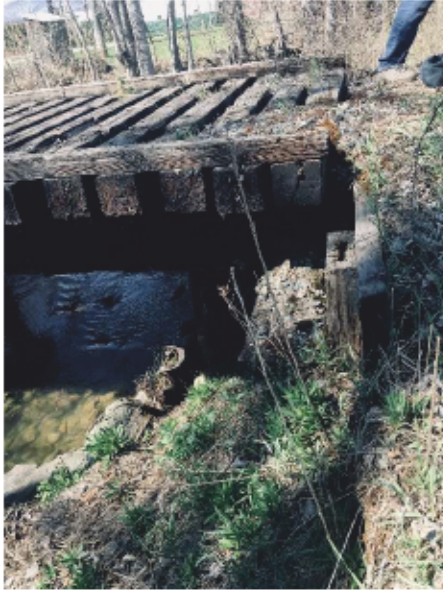
FIGURE 5.2.14-ABUTMNET A &amp; BEARING LINE 1

5. Abutments- 4"x12" creosote treated built up members.
  - a. Overall the abutments for this bridge are in poor condition.
  - b. Abutment A (Grid Line 1 in Figure 5.1.3) is about 6'-0" or 6 visible courses high and showed signs of fatigue. Only some of the abutment was visible behind bearing line 1. {Figure 5.2.14 & 5.2.16}
  - c. Abutment B (Grid Line 4 Figure 5.1.3) about 4'-0" or 4 visible courses high. This abutment showed signs of fatigue and deterioration. There were noticeable gaps between the abutment members allowing the ground material to penetrate. {Figure 5.2.15 & 5.2.17}

Both existing abutments show signs of fatigue and/or deterioration. BE recommends replacing both abutments with a similar treated built-up abutment. Ideally, excavate from the back and replace the existing railway ties with 6"x12" solid treated timber members. Install  $\frac{3}{4}$ " diameter rods inserted vertically through the solid members @ 16"c/c. Abutment A has additional treated vertical members on its face. Replace and re-install the vertical members to match the original construction. The buried configuration and depth of the abutments is unknown but, is assumed to be in similar condition to the visible portions and will require replacement. The length and height of the new abutments should match the existing where possible and accommodate the site conditions/grade. Refer to the bridge upgrade drawings file (attachment #2) for clarification on the design.

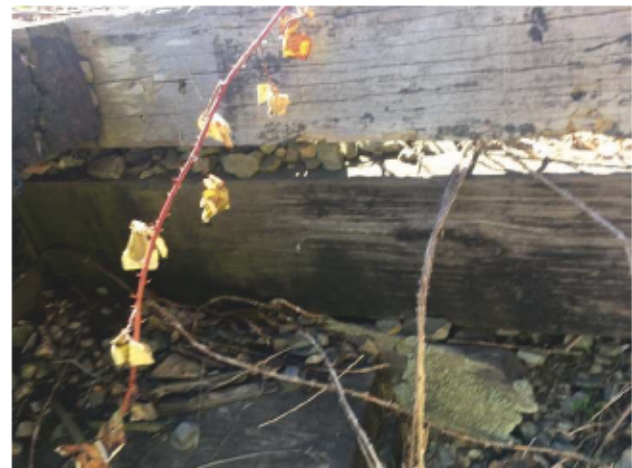
FIGURE 5.2.17-ABUTMETN B-DETERIORATION
