EROSION CONTROL

Memo

Re: Sicamous to Armstrong Rail Trail – Information to Assist Cost Estimate

SICAMOUS TO ARMSTRONG RAIL TRAIL

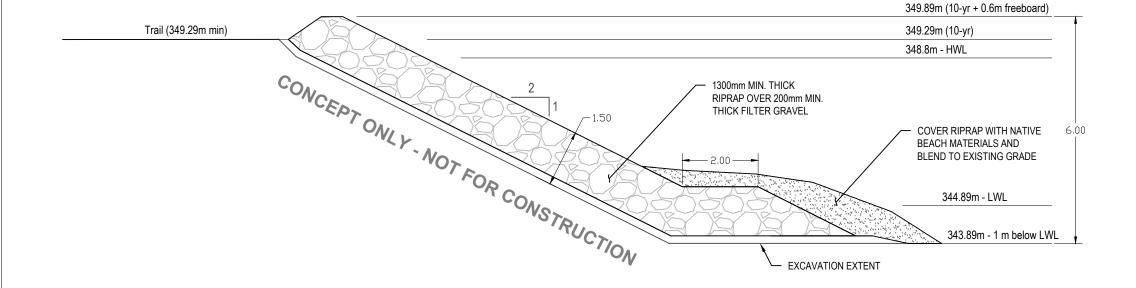
FULL RIPRAP SECTION CONCEPT

"Full Riprap" refers to riprap with a 2H:1V slope (steepest) and minimum two layers of rock thickness. This riprap would extend from 343.89m (1 m below the agreed upon low water level (LWL) for Mara Lake with a keyed-in toe) to 349.89m, which is the estimated water level with a 10-year return period for inundation, plus 0.6m freeboard for waves, or an agreed upon top vertical extent for riprap once LiDAR data is obtained. The riprap should extend above the trail in a trapezoidal berm in places where the elevation of the trail surface is at or below this minimum benchmark elevation. Excavation will be required to embed the riprap toe and containment is anticipated to be required during construction. Locations near private docks (km 1-1.5) have fine gravels, very little vegetation or larger rock and evidence of erosion damage from 2020 flooding. These have been counted in "full riprap". Vegetated flex-MSE or similar alternative products would also work in place of riprap, but private owners may remove the vegetation.
