APPENDIX J

BRIDGES

FROM:	April Creighton, PEng	DATE:	July 17, 2020
PROJECT:	CSRD Rail Trail-Bridge Inspection Summary	FILE:	19-383
ATTENTION:	Phil McIntyre, Shuswap Trail Alliance & Thomas Simkins, Urban Systems Ltd.	PAGES:	1 of 11

Photo Attachment -Rosemond Lake (Km 17)

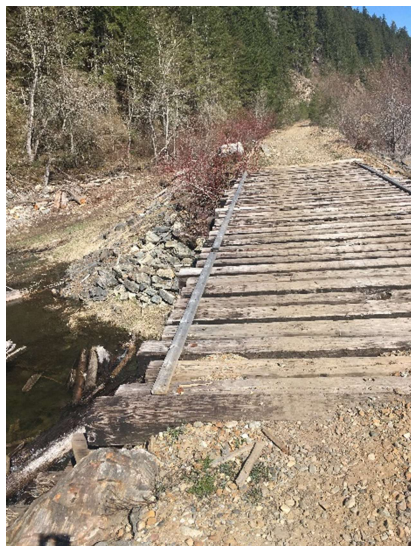
Pic 1-Bridge Deck

- Minimum half of the 43 deck ties show signs of rot and deterioration.
- Multiple piles had 11½"x11½" square timber splices. The splices vary in length but averaged about 3'-0" long. BE assumed this was due to previous remediation work that had occurred.
- The [2] interior support lines have 3"x10" cross bracing.
- Abutment A (south) was in poor condition with noticeable rot and deterioration. A section was supported by plywood and a brace.
- Abutment B (north) was in better shape but still showed signs of fatigue and rot.

BE observed the overall condition of the bridges as good with some remediation work required. It is recommended that all bridge decks be replace. We suggest replacing the ties with a similarly sized treated material, such as 6x8", but at a larger spacing. The exact spacing will be determined by new decking placed over the new deck ties. The decking will provide a safe surface on the bridge for all traffic. A handrail will also be required on all bridges.

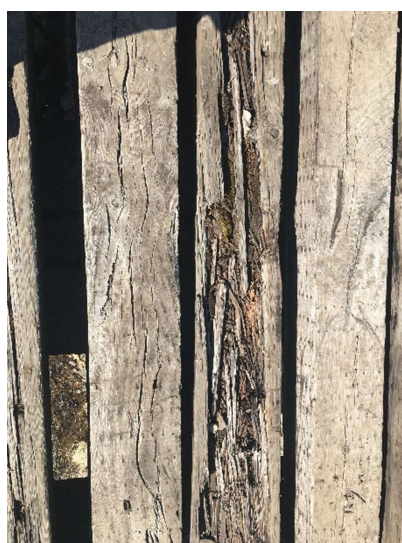
Pic 3-Deck Deterioration

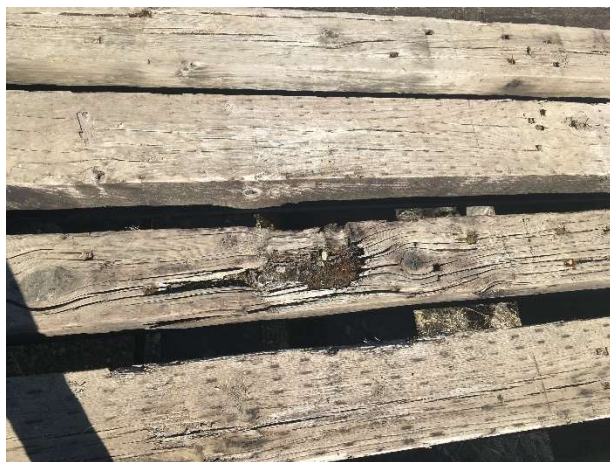
Pic 4-Deck Deterioration

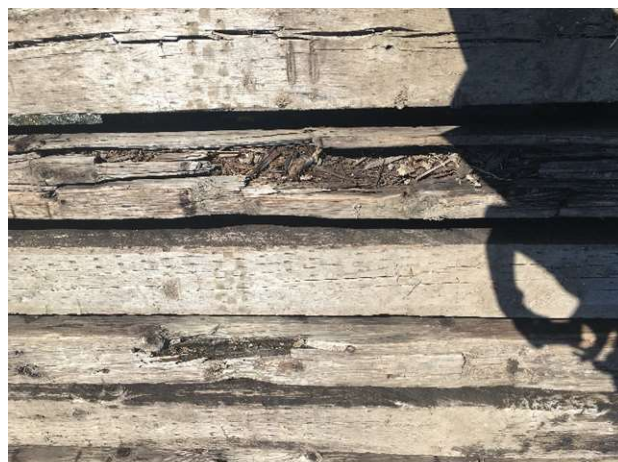
Pic 5-Deck Deterioration

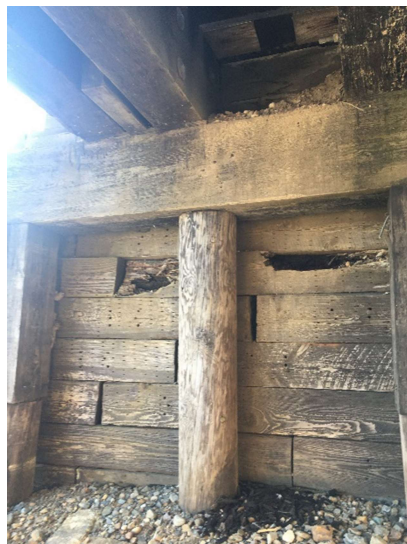
Pic 12-Abutment Deterioration

In addition, it is recommended that all abutments be replaced. Several abutments showed signs of deterioration or rot while the majority of the other showed signs of fatigue and age. BE recommends excavating them from the back and replacing the railway ties with similarly sized treated lumber and vertical rods to increase the stability.

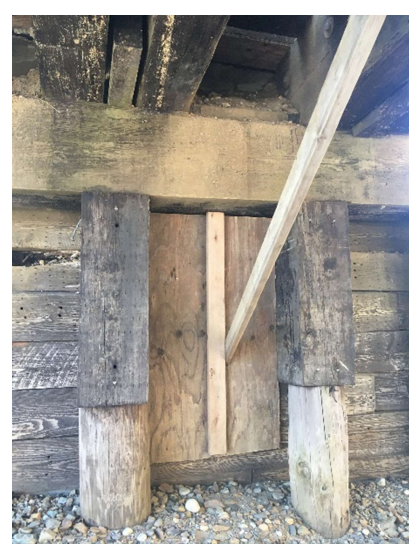
Pic 13-Abutment Deterioration(S)

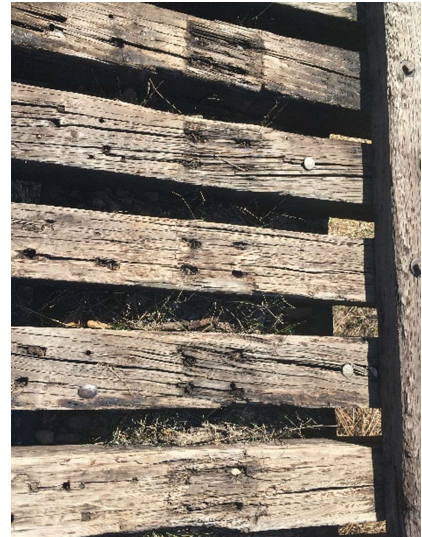
- A portion of the 46 treated deck ties show signs of rot and deterioration.
- The [2] end piles of the interior bearing line were battered. This means they are on an angle to provide additional stability especially against the thrust of the water.
- The [2] interior support lines have 2"x8" cross bracing.
- The piers appeared in overall good condition.
- The main beam and secondary beam were connected using a 6"x4" piece of angle iron.
- Both abutment timbers were in moderate condition but did show signs of fatigue. The bearing lines near the abutments has moss and mildew in some locations.

Pic 18-Deck Deterioration

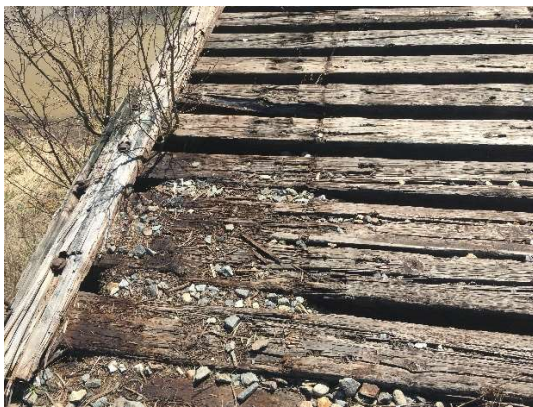
Pic 19- Deck Deterioration

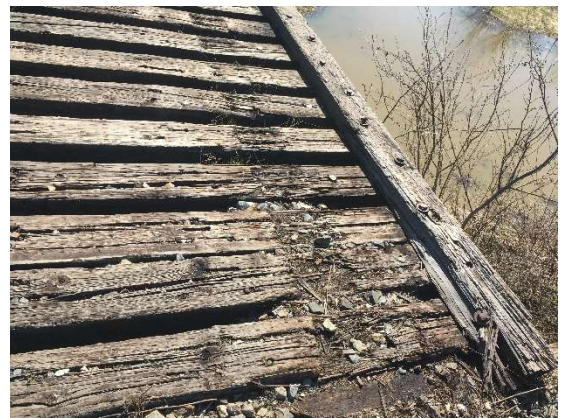
Pic 20-Deck Deterioration

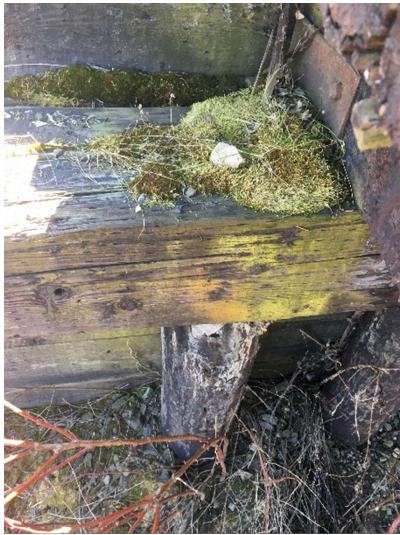
Pic 25- Moss & Mildew

Finally, any members that have moss or mildew on them will need minor remediation work to have that removed. Please refer to the detailed report and construction drawings (not yet released) for each bridge to get a comprehensive explanation of the conditions and upgrade recommendations.

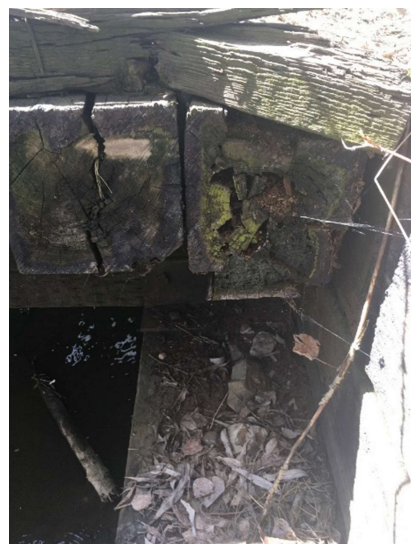
- A portion of the 15 deck ties showed signs of age and deterioration.
- This bridge was shorter and the water line higher than the other bridges. The confirmation of some dimensions was not obtainable.
- The piers were almost completely submerged meaning confirmation of their condition undeterminable at the time of our site visit.
- The secondary beam was visible on both bearing lines.
- Most beams had green mildew along their length.
- The main beam and secondary beam were connected using a 6"x4" piece of angle iron.
- Abutment A (south/west) was in acceptable condition with some signs of fatigue.
- Abutment B (north/east) showed some signs of rot and deterioration.

Pic 32- Deck Ties

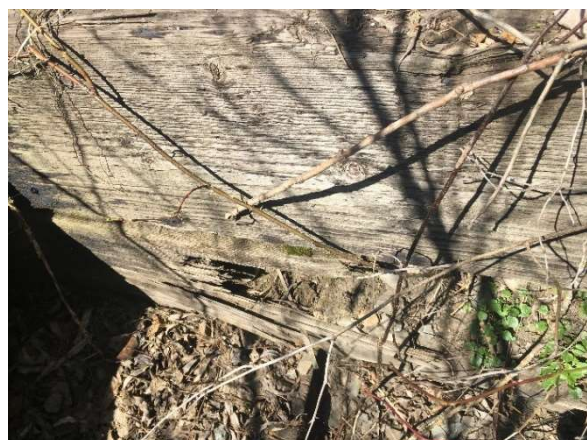
Pic 33- Abutment Deterioration

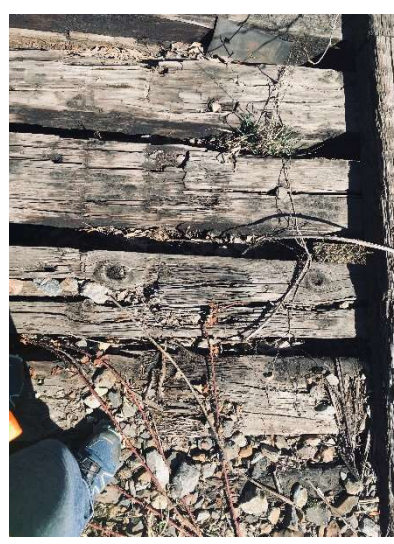
- Some of the 46 deck ties show signs of deterioration and rot.
- The secondary beams came with a 4 x14" top plate.
- Interior bearing line 3 (2nd from west abutment) had rot near the south end.
- The main beam and secondary beam were connected using a 6"x4" piece of angle iron.
- Bearing line 3 (2nd from east abutment) has a double column at 1 location.
- Both abutments were in moderate condition but did show signs of fatigue.
- Piers were in overall good condition.

Pic 41-Tie Deterioration

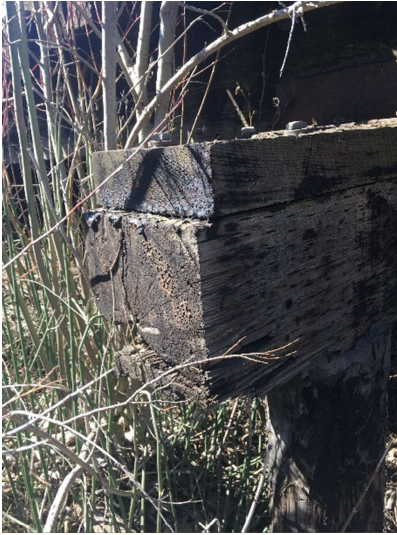
Pic 46- Beam Deterioration
