STORM WATER

THE SHUSWAP TRAIL ALLIANCE SHUSWAP NORTH OKANAGAN RAIL TRAIL STORMWATER MANAGEMENT REPORT

October 28, 2020

Project #: 1928-011

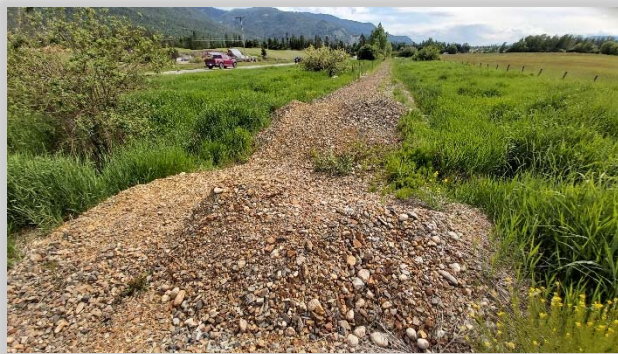
Figure 3.2 – Km 46.45 – Culvert removed

- Km 43.14 – Culvert has been removed at Hussard Creek and a channel has been provided. At time of inspection, water was standing in channel. Upstream from the removed culvert, a 1500mm CSP culvert crosses Stepney Road. See **Figure 3.3**.
- Km 46.45 – Culvert removed, but no channel provided. Water being dammed in the ditch between Highway 97A and the rail trail. At time of inspection, standing water on both sides of rail trail. See **Figure 3.2**.

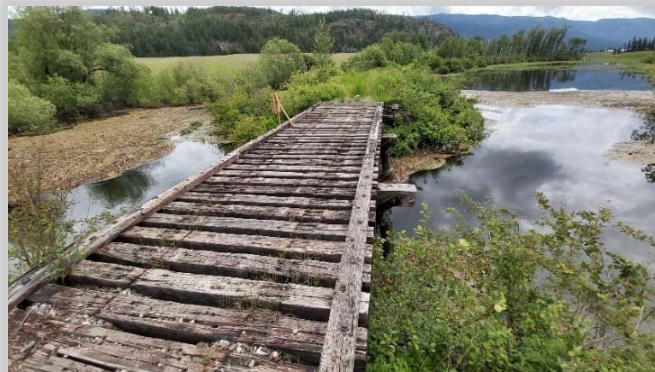
Figure 3.5 – Km 40.60 – Bridge #2

Bridge #2 crosses Fortune Creek at km 40.60, see **Figure 3.5**. The bridge spans approximately 13.35 metres, is about 3.05 metres wide and has two bridge piers. The elevation of the bridge deck is 353.70. At approximately km 36.80 (± 3.8 km downstream), Fortune Creek confluences with the Shuswap River at the City of Enderby. At the confluence location, the 200 year flood level is 353.40 and the 20 year flood level is 352.80. As the bridge is located upstreams from the confluence, it is assumed that the flood levels at the bridge are at a slightly higher elevation. Therefore, it is assumed

that Bridge #2 is at or near the 200 year flood level. The flood levels were obtained from the British Columbia government floodplain maps and include 0.6m freeboard. [4]

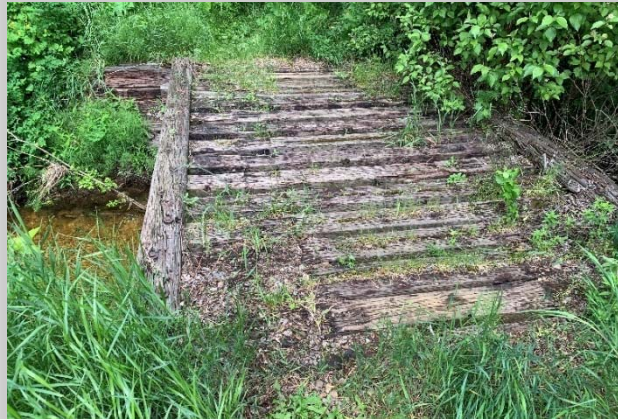
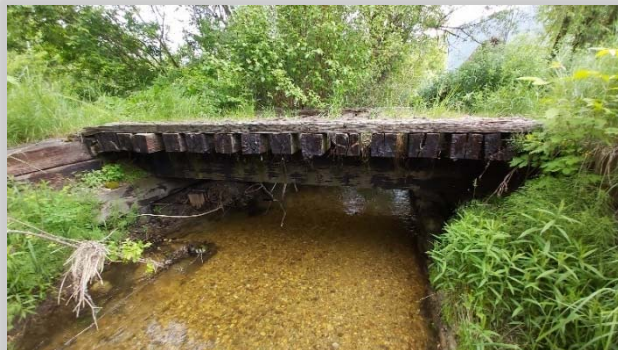
Figure 3.6 – Km 42.53 – Bridge #3

Bridge #3 crosses Harland Creek at km 42.53, see **Figure 3.6**. Harland Creek is a tributary stream of Fortune Creek. The bridge spans approximately 4.60 metres and is about 2.95 metres wide. The elevation of the bridge deck is 353.73.

At the time of inspection on June 10, 2020, Harland Creek at Bridge #3 consisted of fast flowing water with a flow depth of about 0.12 metres. Channel cross sections downstream from the bridge were obtained. However, upstream channel cross sections could not be obtained, due to trees and brush inhibiting the GPS signal. The water level elevation was about 352.54, which corresponds to a freeboard of 1.19 metres to the top of decking.

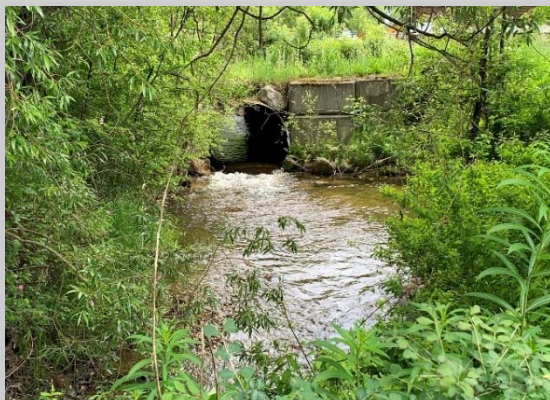
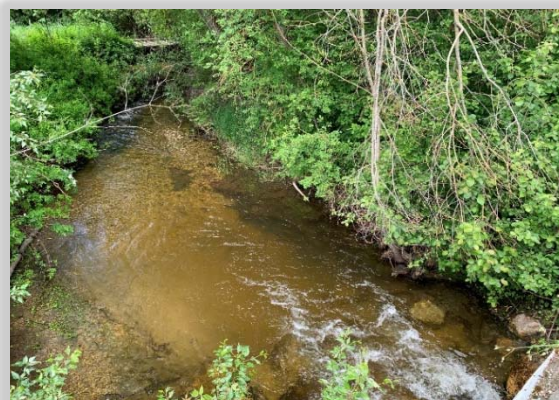
Figure 3.7 – Km 42.53 – Culvert at Stepney Road upstream of Bridge #3

About 19 metres upstream, a 2000mm CSP culvert crosses Stepney Road, see **Figure 3.7**. The water level in the culvert was 352.76. However, sediments were present on the culvert floor.

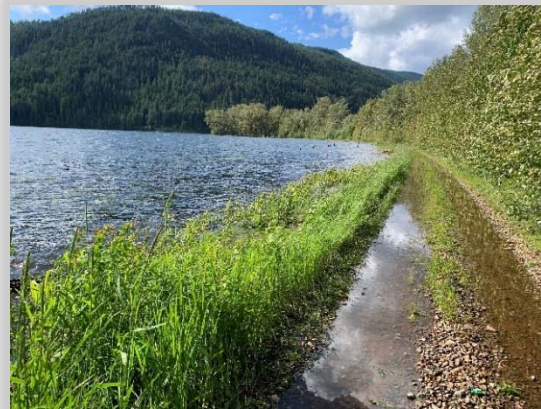
Figure 3.14 – Km 15.20 – 15.80 – Lake water spilling onto rail bed

- Km 0.00 – 14.80 – Standing water was observed within ditches in low lying areas along the west side of the rail trail. Based on our observations, this water is associated to groundwater/lake water backing up from Mara Lake due to the rail corridor's close proximity to Mara Lake and the ditch bottom elevations being below current lake levels. See **Figure 3.12**.
- Km 1.70 – Standing water in west ditch.
- Km 3.30 – Significant sediments and water in ditch. Possibly previous flooding. See **Figure 3.13**.
- Km 15.20 – 15.80 – Lake water spilling over the rail bed at an approximate depth of 0.15m. See **Figure 3.14**.
- Km 20.50 – Standing water in west ditch.

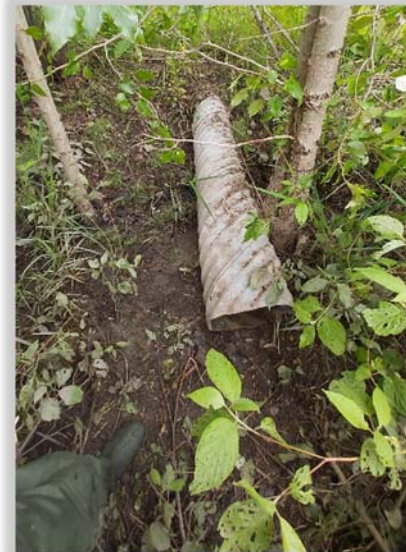
Figure 4.4 – Km 37.17 – Culvert #21

27 out of 29 (93%) culverts were determined to be fish-bearing. Two (2) culverts were determined to be non-fish bearing and are located at km 12.44 (Culvert #9) and km 37.17 (Culvert #21), see **Figure 4.4**. Culvert #9 has a downstream water drop of about 1 metre onto rocks below making fish access impossible. Culvert #21 was dry at the time of inspection on June 10, 2020 and drops over 2.15 metres in elevation over its length. This means that fish can only access Culvert #21 during high flow events on Fortune Creek, but cannot pass through due to the elevation difference between the upstream and downstream culvert ends. Fish would only be able to access the upstream end of the culvert at or exceeding a 200 year flood event.

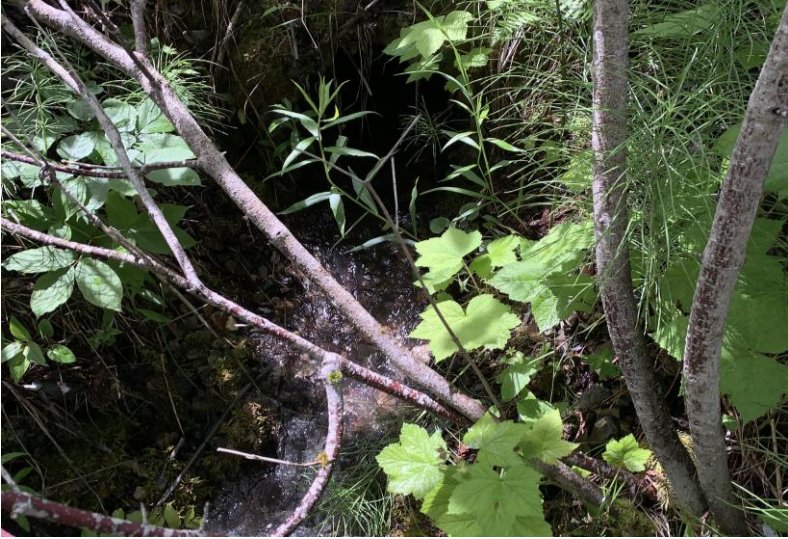
CULVERT #8 - KM 12.32
 SICAMOUS TO ARMSTRONG RAIL TRAIL
 STORMWATER MANAGEMENT
 Project No. 1928-011

Date Inspected:		June 8, 2020	
		WWAL ID:		n/a	
		CULVERT:			
		Diameter (mm):		400	
		Material:		CSP	
		Length (m):		5.5	
		Mitered:		n/a	
		Projection Length (m):			
		US:	n/a	DS:	n/a
		Invert (m):			
US:	351.53	DS:	351.22		
Top of Rail Bed (m):		352.54			
Cover (m):		0.77			
Rail Bed Condition:		Good			
Pipe Condition:		Good Some visible corrosion on culvert floor			
Inlet:		Overgrown with vegetation			
Outlet:		Some overgrown vegetation			
Headwall:	US:	n/a			
	DS:	n/a			
Rip Rap:	US:	n/a	DS:	n/a	
Trash Rack:		n/a			
STREAM:					
Flow Type/Source:		Ditch flow - draining towards Mara Lake			
Water Depth (m):		0.09	Water Level Width (m):		0.50
Freeboard (m):		0.92			
High Water:	No	Scour:	No	Debris:	No
Aggradation:		Yes			
COMMENTS:					
Discolouration/possible high water mark about halfway up in culvert, some sediments in ditch at inlet					
REPAIR:					
Repair Priority:		Low			
Repair/Action Item:		None

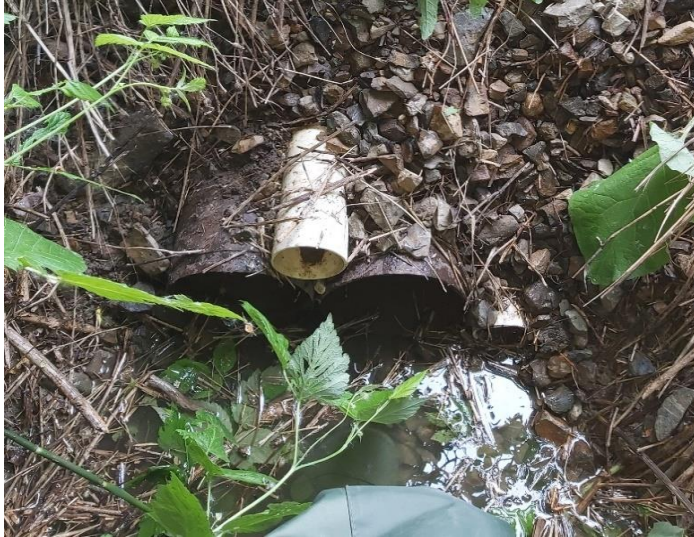
Date Inspected:	June 9, 2020		
WWAL ID:	n/a		
CULVERT:			
Diameter (mm):	2-150 & 2-75		
Material:	CI & PVC		
Length (m):	6.0		
Mitered:	n/a		
Projection Length (m):			
US:	n/a	DS:	n/a
Invert (m):			
US:	349.38	DS:	349.26
Top of Rail Bed (m):	350.58		
Cover (m):	1.11		
Rail Bed Condition:	Good

Pipe Condition:		Poor Not a proper culvert. Filled with rocks and sediments. Undersized.						
Inlet:		Poor condition						
Outlet:		50% filled with rocks and sediments						
Headwall:	US:	n/a						
	DS:	n/a						
Rip Rap:	US:	n/a			DS:	n/a		
Trash Rack:		n/a						
STREAM:								
Flow Type/Source:		Ditch flow - draining towards the Shuswap River						
Water Depth (m):		0.07	Water Level Width (m):			River	Freeboard (m):	1.13
High Water:		Yes	Scour:	No	Debris:	No	Aggradation:	Yes
COMMENTS:								
Flooded Shuswap River backing into culverts. Outlet filled with rocks, rocks removed to inspect culvert.								
REPAIR:								
Repair Priority:		High						
Repair/Action Item:		Remove and replace with higher capacity culvert.

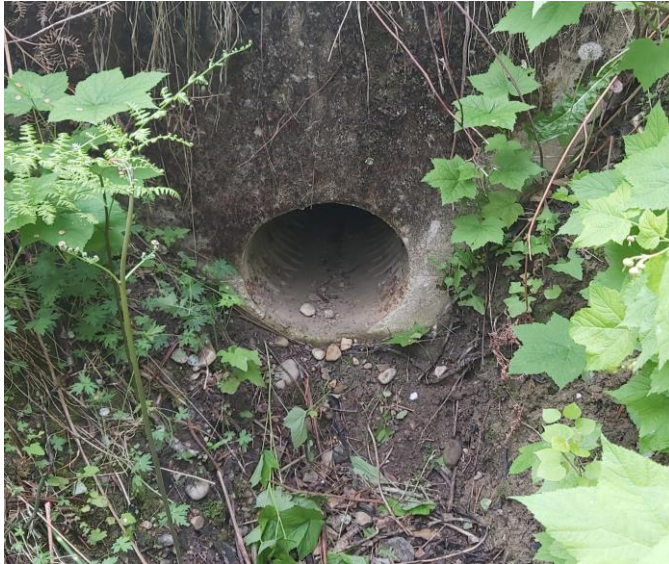
CULVERT #13 - KM 21.66
 SICAMOUS TO ARMSTRONG RAIL TRAIL
 STORMWATER MANAGEMENT
 Project No. 1928-011

Date Inspected:		June 9, 2020	
WWAL ID:		n/a	
CULVERT:			
Diameter (mm):		450	
Material:		CSP	
Length (m):		6.0	
Mitered:		n/a	
Projection Length (m):			
US:	n/a	DS:	n/a
Invert (m):			
US:	350.05	DS:	350.07
Top of Rail Bed (m):		351.58	
Cover (m):		1.07	
Rail Bed Condition:		Good

Pipe Condition:	Fair Scattered visible corrosion with varying severity. Sediments and rocks in culvert. Culvert is flat.		
Inlet:	Some sediments and significant corrosion.		
Outlet:	Some sediments and significant corrosion.		
Headwall:	US:	Concrete headwall - overgrown.	
	DS:	Concrete headwall - overgrown.	
Rip Rap:	US:	n/a	DS: n/a
Trash Rack:	n/a

Repair Priority:	Medium
Repair/Action Item:	Replace, some corrosion.

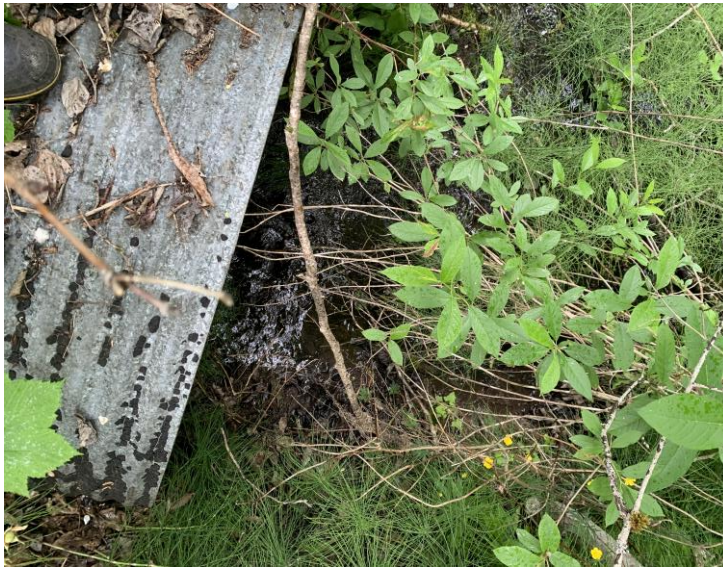
CULVERT #14 - KM 23.25
 SICAMOUS TO ARMSTRONG RAIL TRAIL
 STORMWATER MANAGEMENT
 Project No. 1928-011

Date Inspected:		June 9, 2020	
WWAL ID:		n/a	
CULVERT:			
Diameter (mm):		1400	
Material:		CSP	
Length (m):		11.0	
Mitered:		n/a	
Projection Length (m):			
US:	0.9	DS:	2.0
Invert (m):			
US:	351.21	DS:	350.92
Top of Rail Bed (m):		353.87	
Cover (m):		1.41	
Rail Bed Condition:		Good

Pipe Condition:	Good Some sediments		
Inlet:	Significant sediments (± 0.3 m)		
Outlet:	Some sediment		
Headwall:	US:	n/a	
	DS:	n/a	
Rip Rap:	US:	n/a	DS: n/a
Trash Rack:	n/a

Repair Priority:	Low
Repair/Action Item:	Good condition, clean out sediments.

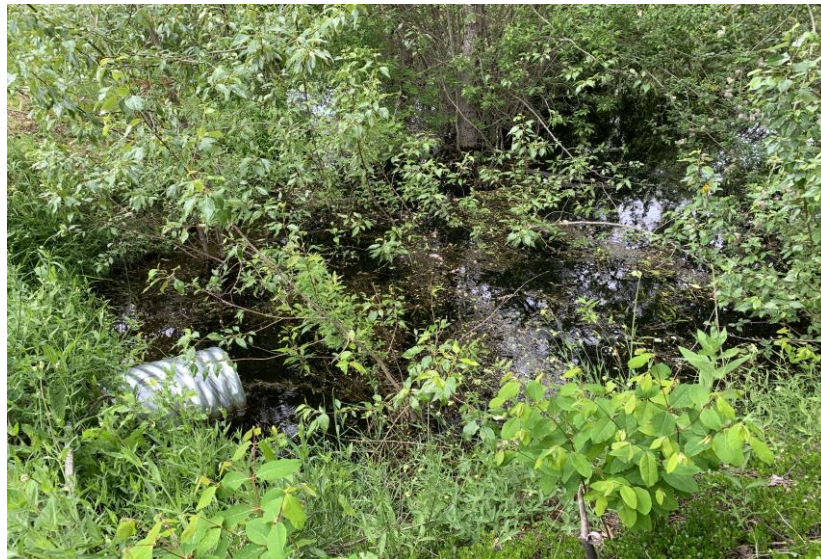
CULVERT #15 - KM 23.94
 SICAMOUS TO ARMSTRONG RAIL TRAIL
 STORMWATER MANAGEMENT
 Project No. 1928-011

Date Inspected:	June 9, 2020		
WWAL ID:	n/a		
CULVERT:			
Diameter (mm):	600		
Material:	CSP		
Length (m):	23.0		
Mitered:	n/a		
Projection Length (m):			
US:	0.6	DS:	0.5
Invert (m):			
US:	352.24	DS:	352.34
Top of Rail Bed (m):	353.64		
Cover (m):	0.75		
Rail Bed Condition:	Good

Pipe Condition:	Good Slight rise - negative slope, some very minor corrosion has started		
Inlet:	75% submerged, culvert invert above channel invert (± 0.39 m)		
Outlet:	Invert higher than US Invert - reduced capacity		
Headwall:	US:	n/a	
	DS:	n/a	
Rip Rap:	US:	n/a	DS: n/a
Trash Rack:	n/a

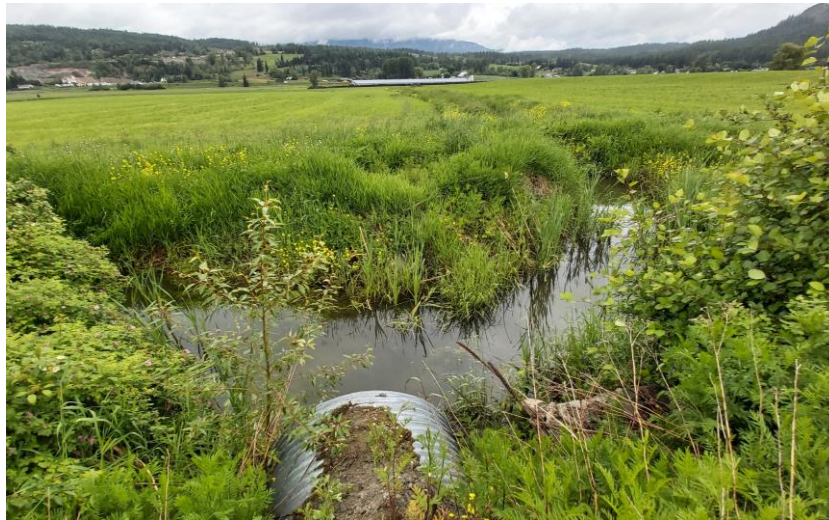
CULVERT #17 - KM 30.43
 SICAMOUS TO ARMSTRONG RAIL TRAIL
 STORMWATER MANAGEMENT
 Project No. 1928-011

Date Inspected:		June 9, 2020	
WWAL ID:		Culvert #10	
CULVERT:			
Diameter (mm):		1500	
Material:		CSP	
Length (m):		12.0	
Mitered:		n/a	
Projection Length (m):			
US:	1.5	DS:	2.0
Invert (m):			
US:	349.71	DS:	349.68
Top of Rail Bed (m):		352.19	
Cover (m):		1.00	
Rail Bed Condition:		Good

Pipe Condition:	Excellent 40% submerged, some sediments		
Inlet:	Excellent condition		
Outlet:	Scour pool ($\pm 0.45\text{m}$)		
Headwall:	US:	n/a	
	DS:	n/a	
Rip Rap:	US:	n/a	DS: n/a
Trash Rack:	n/a

Repair Priority:	Low
Repair/Action Item:	Looks brand new, clean out some sediments.

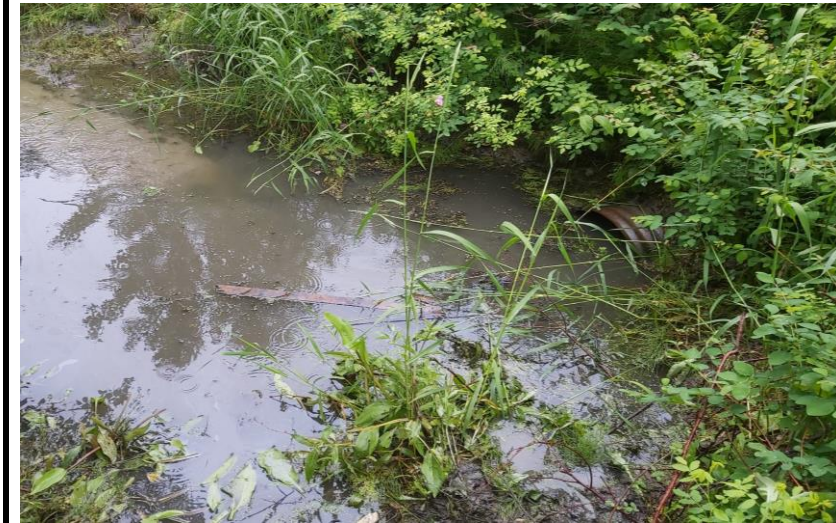
CULVERT #18 - KM 32.55
 SICAMOUS TO ARMSTRONG RAIL TRAIL
 STORMWATER MANAGEMENT
 Project No. 1928-011

Date Inspected:	June 9, 2020		
WWAL ID:	n/a		
CULVERT:			
Diameter (mm):	600		
Material:	CSP		
Length (m):	11.0		
Mitered:	n/a		
Projection Length (m):			
US:	n/a	DS:	n/a
Invert (m):			
US:	350.54	DS:	350.50
Top of Rail Bed (m):	353.10		
Cover (m):	1.98		
Rail Bed Condition:	Good

Pipe Condition:	Poor Severe corrosion, damaged - reduced capacity, 80% submerged		
Inlet:	Severe corrosion, 80% submerged		
Outlet:	Culvert end squished - only 50% capacity, severe corrosion , 75% submerged		
Headwall:	US:	n/a	
	DS:	n/a	
Rip Rap:	US:	n/a	DS: n/a
Trash Rack:	n/a

Repair Priority:	High
Repair/Action Item:	Corroded and damaged - replace.

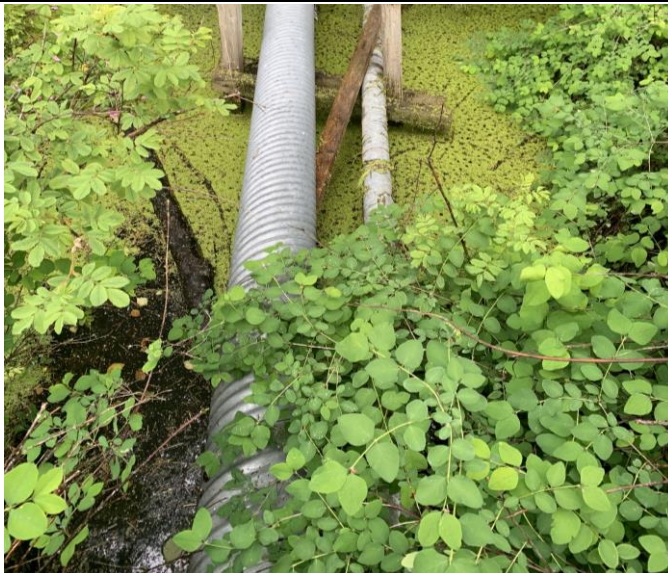
CULVERT #19 - KM 31.65
 SICAMOUS TO ARMSTRONG RAIL TRAIL
 STORMWATER MANAGEMENT
 Project No. 1928-011

Date Inspected:	June 9, 2020		
WWAL ID:	n/a		
CULVERT:			
Diameter (mm):	2000		
Material:	CSP		
Length (m):	9.0		
Mitered:	Yes		
Projection Length (m):			
US:	n/a	DS:	n/a
Invert (m):			
US:	no shot	DS:	349.34
Top of Rail Bed (m):	352.37		
Cover (m):	1.03		
Rail Bed Condition:	Good

Pipe Condition:	Good 68% submerged in standing water, pipes within the culvert reduce capacity		
Inlet:	68% submerged, mitered end		
Outlet:	68% submerged, not able to access fully due to brush		
Headwall:	US:	n/a	
	DS:	n/a	
Rip Rap:	US:	n/a	DS: n/a
Trash Rack:	n/a

Repair Priority:	Low
Repair/Action Item:	Some cleaning, may consider removing pipes within the culvert

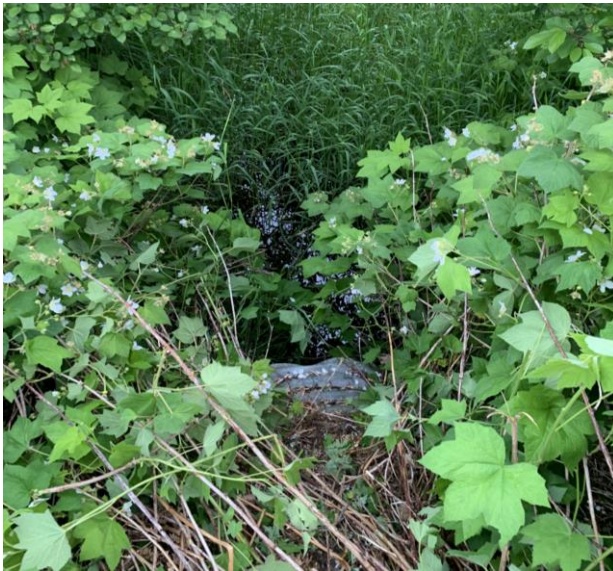
CULVERT #20 - KM 20.24
 SICAMOUS TO ARMSTRONG RAIL TRAIL
 STORMWATER MANAGEMENT
 Project No. 1928-011

Date Inspected:		June 9, 2020	
WWAL ID:		n/a	
CULVERT:			
Diameter (mm):		600	
Material:		CSP	
Length (m):		9.0	
Mitered:		n/a	
Projection Length (m):			
US:	n/a	DS:	n/a
Invert (m):			
US:	349.61	DS:	349.27
Top of Rail Bed (m):		351.33	
Cover (m):		1.29	
Rail Bed Condition:		Good

Pipe Condition:	Good Some mild corrosion starting on culvert floor, internal culvert coating is flaky, some sediments		
Inlet:	Good condition		
Outlet:	Good condition, some sediments and overgrown vegetation		
Headwall:	US:	n/a	
	DS:	na/	
Rip Rap:	US:	n/a	DS: n/a
Trash Rack:	n/a

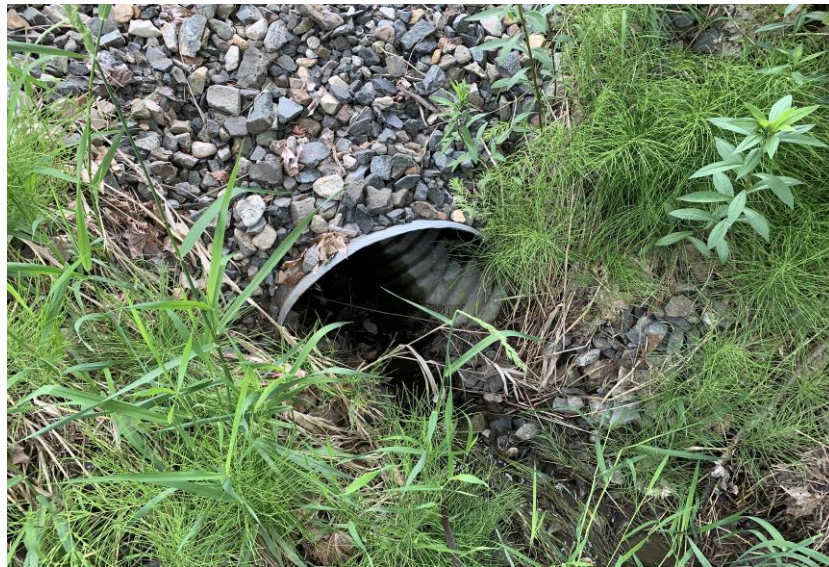
Date Inspected:		June 10, 2020	
WWAL ID:		n/a	
CULVERT:			
Diameter (mm):		600	
Material:		CSP	
Length (m):		12.0	
Mitered:		n/a	
Projection Length (m):			
US:	n/a	DS:	0.6
Invert (m):			
US:	356.17	DS:	355.12
Top of Rail Bed (m):		357.53	
Cover (m):		1.29	
Rail Bed Condition:		Good

Pipe Condition:		Good Some corrosion on culvert floor, coating gone on floor, remaining coating is flaky	
Inlet:		Some ballast rock at inlet	
Outlet:		Good condition	
Headwall:	US:	n/a	
	DS:	n/a	
Rip Rap:	US:	n/a	DS: n/a
Trash Rack:		n/a

Repair Priority:	Low
Repair/Action Item:	Clean out inlet end and prevent ballast from entering culvert

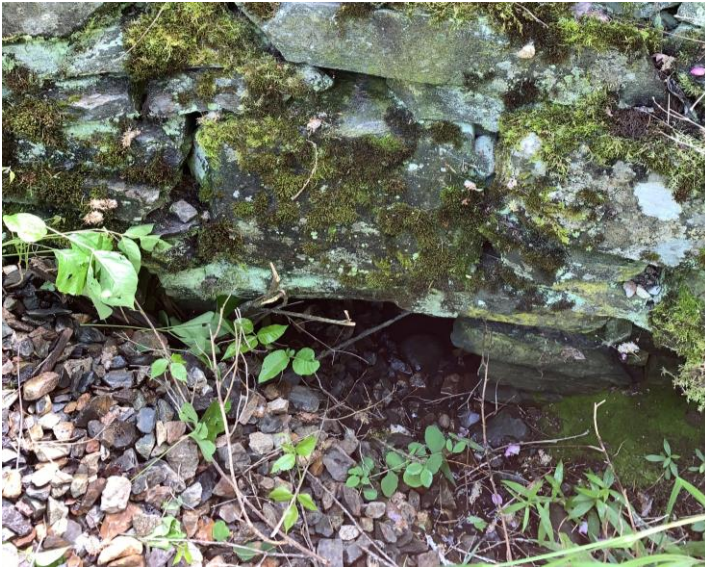
CULVERT #23 - KM 40.0
 SICAMOUS TO ARMSTRONG RAIL TRAIL
 STORMWATER MANAGEMENT
 Project No. 1928-011

Date Inspected:		June 10, 2020	
WWAL ID:		n/a	
CULVERT:			
Diameter (mm):		600	
Material:		CSP	
Length (m):		8.0	
Mitered:		n/a	
Projection Length (m):			
US:	n/a	DS:	n/a
Invert (m):			
US:	351.95	DS:	no shot
Top of Rail Bed (m):		354.56	
Cover (m):		2.01	
Rail Bed Condition:		Good

Pipe Condition:	Good 30% filled with rocks		
Inlet:	Rocks sliding into inlet, top of culvert end deflected		
Outlet:	Not able to access due to unsafe slope & toppling headwall rocks		
Headwall:	US:	Rocks utilized as headwall	
	DS:	Rocks utilized as headwall	
Rip Rap:	US:	n/a	DS: n/a
Trash Rack:	n/a

Repair Priority:	Medium
Repair/Action Item:	Clean out rocks from culvert and remove tree/vegetation at outlet

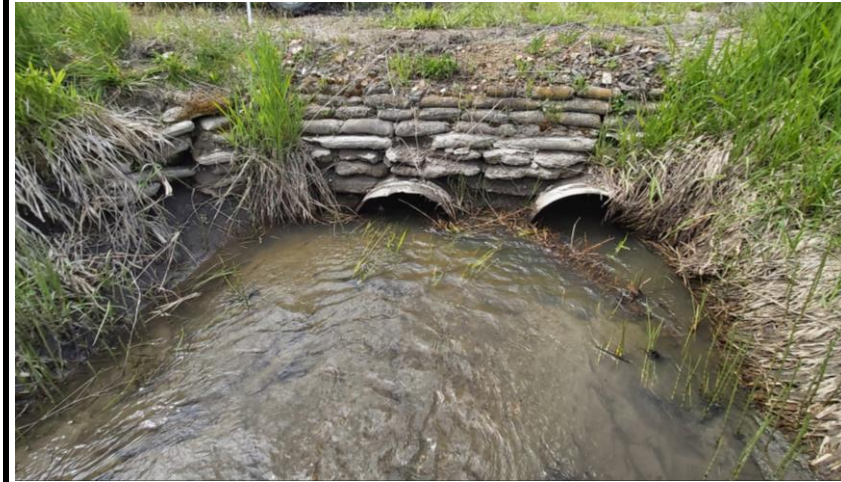
CULVERT #24 - KM 44.42
 SICAMOUS TO ARMSTRONG RAIL TRAIL
 STORMWATER MANAGEMENT
 Project No. 1928-011

Date Inspected:		June 10, 2020	
WWAL ID:		Culvert #11	
CULVERT:			
Diameter (mm):		2 - 600	
Material:		CSP	
Length (m):		6.0	
Mitered:		n/a	
Projection Length (m):			
US:	n/a	DS:	n/a
Invert (m):			
US:	351.89	DS:	351.74
Top of Rail Bed (m):		353.27	
Cover (m):		0.86	
Rail Bed Condition:		Good

Pipe Condition:	Poor Some corrosion, filled 35% with sediments, 60% submerged, coating is flaking off. Both culverts are in similar condition.		
Inlet:	35% filled with sediment		
Outlet:	50% filled with sediment		
Headwall:	US:	Concrete sandbag headwall - erosion headwall and wing wall being undermined	
	DS:	n/a	
Rip Rap:	US:	n/a	DS: n/a
Trash Rack:	n/a

Repair Priority:	High
Repair/Action Item:	Clean out channel, replace culvert and headwall

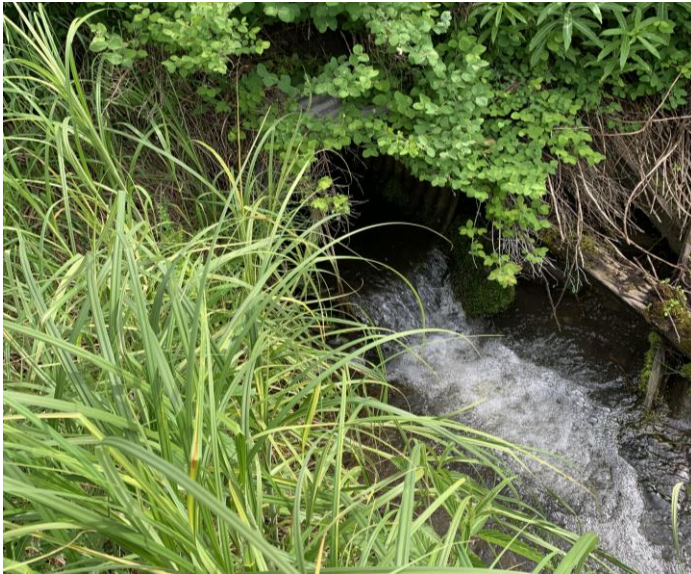
CULVERT #28 - KM 47.59
 SICAMOUS TO ARMSTRONG RAIL TRAIL
 STORMWATER MANAGEMENT
 Project No. 1928-011

Date Inspected:		June 10, 2020	
WWAL ID:		n/a	
CULVERT:			
Diameter (mm):		800	
Material:		CSP	
Length (m):		8.0	
Mitered:		n/a	
Projection Length (m):			
US:	n/a	DS:	n/a
Invert (m):			
US:	355.59	DS:	355.24
Top of Rail Bed (m):		356.78	
Cover (m):		0.57	
Rail Bed Condition:		Good

Pipe Condition:	Fair Visible corrosion on culvert floor		
Inlet:	Some erosion and scouring		
Outlet:	Scour pool, some erosion		
Headwall:	US:	n/a	
	DS:	n/a	
Rip Rap:	US:	n/a	DS: n/a
Trash Rack:	n/a

Repair Priority:	Medium
Repair/Action Item:	Corrosion - replace

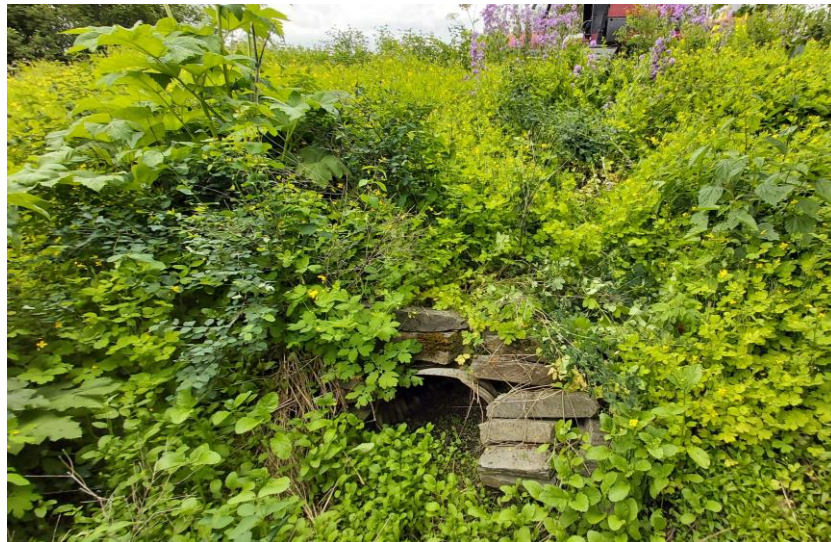
CULVERT #29 - KM 48.20
 SICAMOUS TO ARMSTRONG RAIL TRAIL
 STORMWATER MANAGEMENT
 Project No. 1928-011

Date Inspected:	June 10, 2020		
WWAL ID:	Culvert #12		
CULVERT:			
Diameter (mm):	600		
Material:	CSP		
Length (m):	10.0		
Mitered:	n/a		
Projection Length (m):			
US:	n/a	DS:	n/a
Invert (m):			
US:	355.99	DS:	no shot
Top of Rail Bed (m):	358.48		
Cover (m):	1.89		
Rail Bed Condition:	Good

Pipe Condition:	Poor Culvert caved in or downstream culvert end squished - culvert damaged		
Inlet:	25% filled with sediments		
Outlet:	High headwall, overgrown, unsafe to access		
Headwall:	US:	Rocks utilized as headwall	
	DS:	Rocks utilized as headwall	
Rip Rap:	US:	n/a	DS: n/a
Trash Rack:	n/a

Cave-in or downstream culvert end squished observed at the upstream end by looking through the culvert - downstream end could not be accessed safely

Repair Priority:	High
Repair/Action Item:	Replace - damaged culvert
