FROM:	April Creighton, P Eng Bourcet Engineering	DATE:	May 5, 2021
		FILE:	19-383
ATTENTION:	Phil McIntyre, Shuswap Trail Alliance & Thomas Simkins, Urban Systems Ltd.	EMAIL:	<a href="mailto:phil@shuswaptrails.com">phil@shuswaptrails.com</a> <a href="mailto:tsimkins@urbansystems.ca">tsimkins@urbansystems.ca</a>

# CSRD RAIL TRAIL BRIDGE ASSESSMENT

June 11 2021

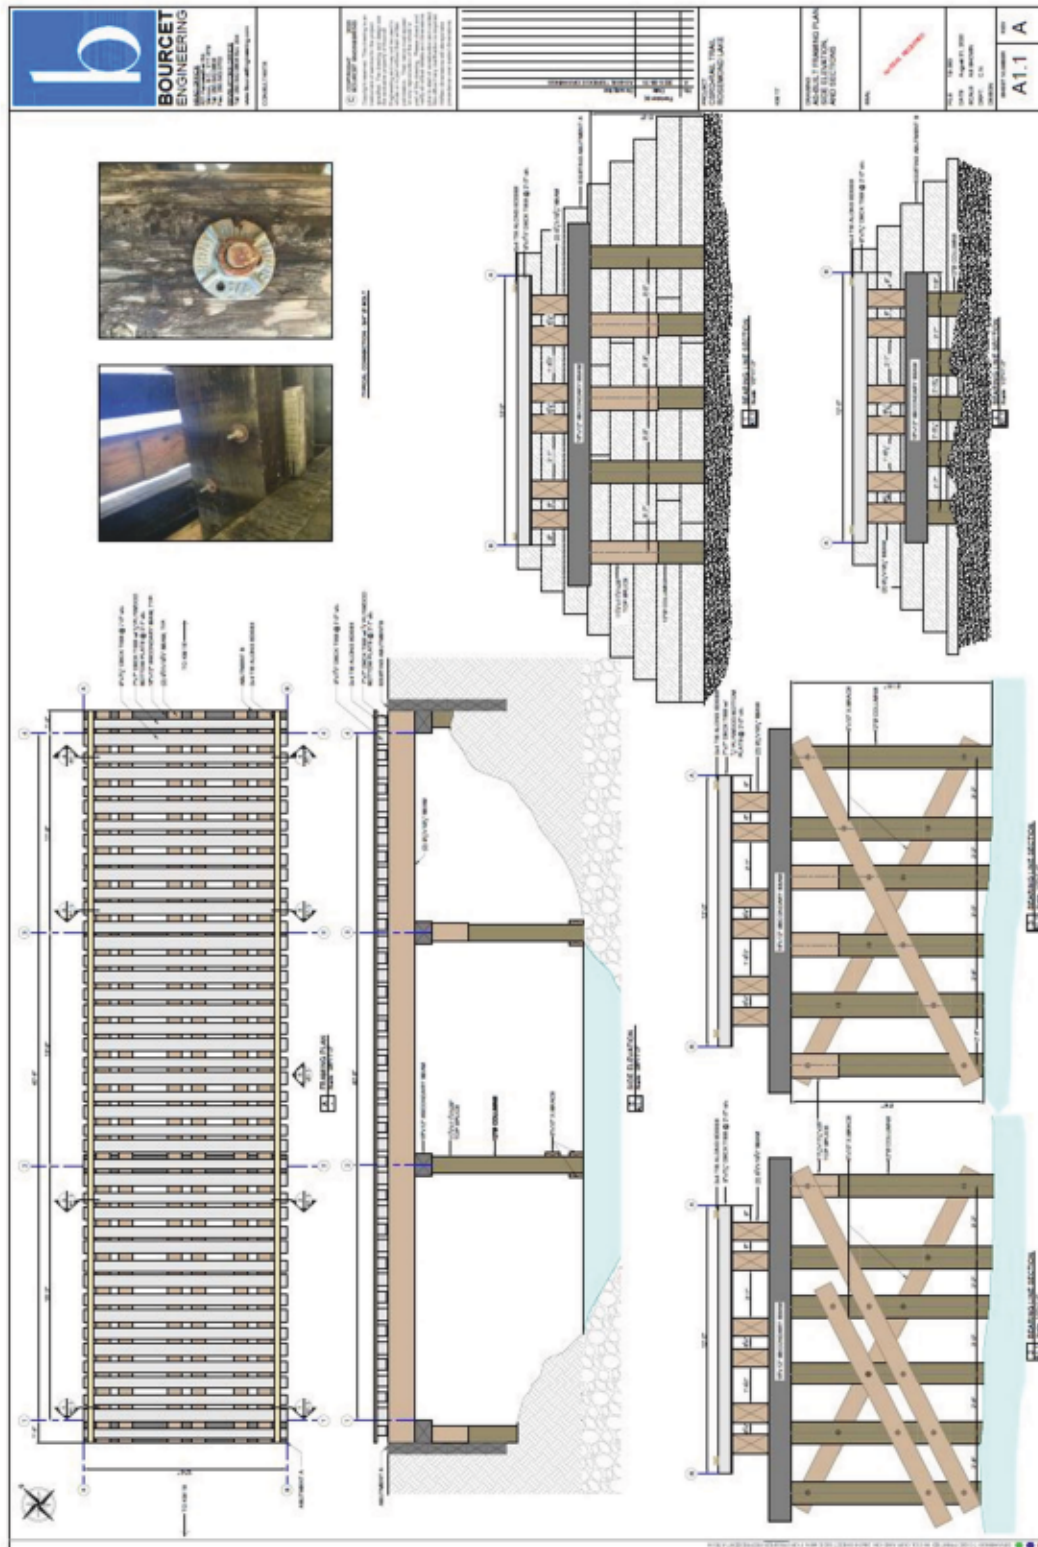
FIGURE 2.1.3-ROSMOND LAKE BRIDGE- EXISTING AS-BUILT INFORMATION

The main beams are supported by [4] bearing lines; [1] at each end and [2] interior lines situated 15'-5" from abutment A and 11'-9" from abutment B. The 16"x12" secondary beams are supported by either [5] or [6] 12" diameter piles. The piles are vertical and embedded into the riverbed or grade at unknown depths. An average pile height of 8'-6" was measured from top of grade to underside of secondary beam, for the interior bearing lines. The [2] interior bearing lines have 3"x10" cross braces on both sides. Some piles appear to have had previous remediation work completed. This is apparent by the 11½"x11½"x2'-0" deep square pile splices observed in various locations. Reference Figure 2.1.3 and attachment #1 S1.1 for layout drawings of the existing Rosemond Lake bridge.

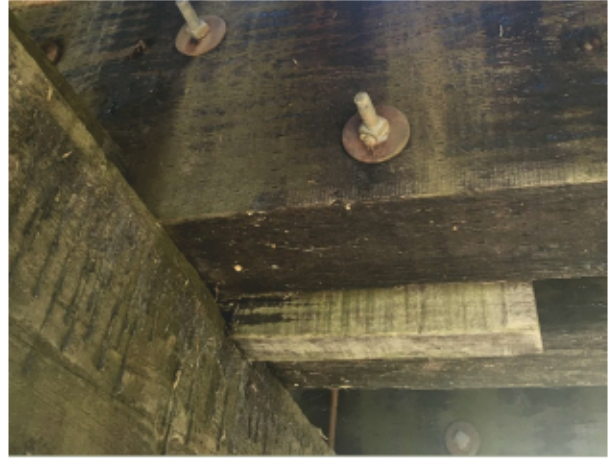
FIGURE 2.2.4- SPACER CONNECTION

2. Main Beams (3 total)- [2] ply 9½"x19½" solid treated timbers approximately 6" apart. {Figure 2.2.3}
  - a. Maximum spacing of 2'-1" between main beam lines.
  - b. Maximum span 15'-2" and minimum span 11'-9".
  - c. Overall beam condition is good. A drip cap over the beams helped to preserve the beam conditions.
  - d. Beam spacer/anchor at each bearing line where [2] ¾" diameter thru bolts are located; refer to Figure 2.2.3 and Figure 2.2.4.
3. Secondary Beams (4 total)- 16"x12" creosote treated solid timbers. {Figure 2.2.5 & Figure 2.2.6}
  - a. Typical beam length of 16'-0" with an average 1'-4" overhang from pile ends.
  - b. Overall beam condition is good with no visible deterioration or rot observed.
  - c. Spacers from main beam notched at secondary beam locations to provide top saddle for stability of secondary beam. {Figure 2.2.4}

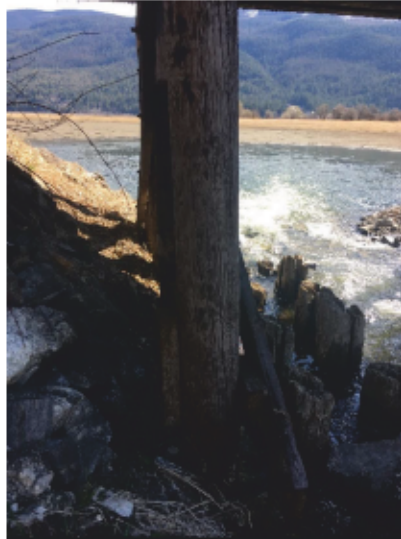
FIGURE 2.2.8-EXISTING &amp; PREVIOUS PLIES

4. Piles-average 12" diameter creosote treated piles. {Figure 2.2.7}
  - a. Embedded into the earth or water at unknown depths.
  - b. All the piles have a vertical alignment. {Figure 2.2.8}
  - c. There are 4 bearing lines with either 5 or 6 piles per bearing line.
  - d. Pile heights vary as grade varies with a maximum visible height of 9'-0".
  - e. Overall pile condition is good with signs of previous remediation work. The remediation work consisted of replacing sections of piles with treated 11½"x11½"x25" deep (average) treated members as shown in Figure 2.2.9.
  - f. There were signs of abandoned piles near the bearing line 11'-9" from abutment B. There were assumed to have been from a previous bearing line that was moved/replaced by CPR prior to the decommissioning of the line. {Figure 2.2.8}

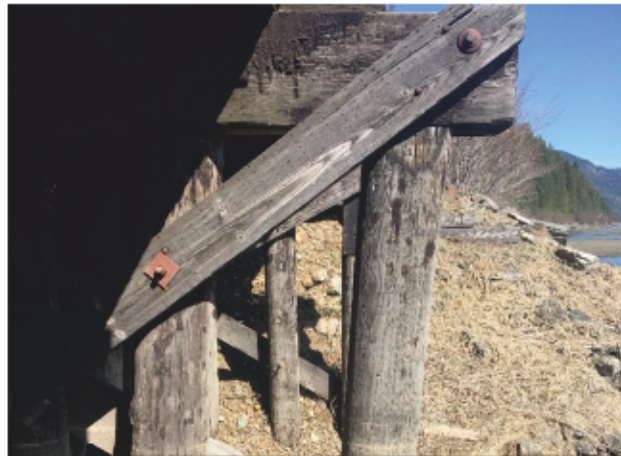
FIGURE 2.2.11-BRACE CONNECTION

- a. Cross bracing observed on interior bearing lines only.
- b. Typically, 1 brace per side in opposite orientation to create an "X" as shown in Figure 2.2.10. Some had multiple brace members per side
- c. Braces anchored with  $\frac{3}{4}$ " diameter thru bolts and large washers to piles similar to other connections. {Figure 2.2.11}

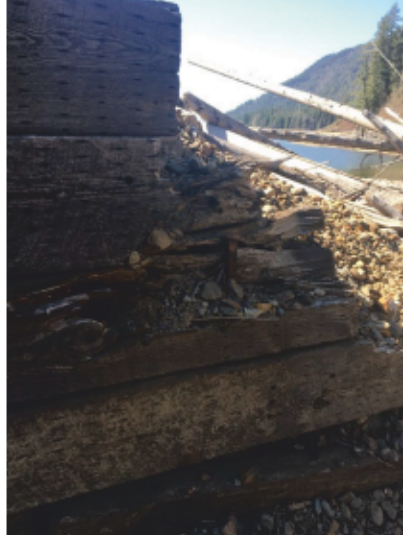
FIGURE 2.2.14-ABUTMENT A

- a. Overall the abutments for this bridge were in poor condition.
- b. Abutment A (Grid Line 1 in Figure 2.1.3) about 8'-0" or 8 visible courses high. This abutment had multiple locations of deterioration, rot and fatigue throughout. {Figure 2.2.12 and 2.2.13}
- c. A section of abutment A had been previously remediated and was supported by plywood, and a brace back to the main bridge beam. {Figure 2.2.14}
- d. Abutment B (Grid Line 4 Figure 2.1.3) about 5'-0" or 5 visible courses high. This abutment showed signs of fatigue [Figure 2.2.15].

Both existing abutments show signs of fatigue and deterioration with abutment A having previous remediation work visible. BE recommends replacing both abutments with a similar treated built-up abutment. Ideally, excavate from the back and replace the existing railway ties with 6"x12" solid timber treated members. 3/4" diameter rods should be inserted vertically through the solid members @ 16" c/c. The buried configuration (including tie backs etc) and depth of the abutments is unknown but, is assumed to be in a similar condition to the visible portions and will require replacement. The length and height of the new abutments should match the existing where possible and is dictated by the site conditions/grade.

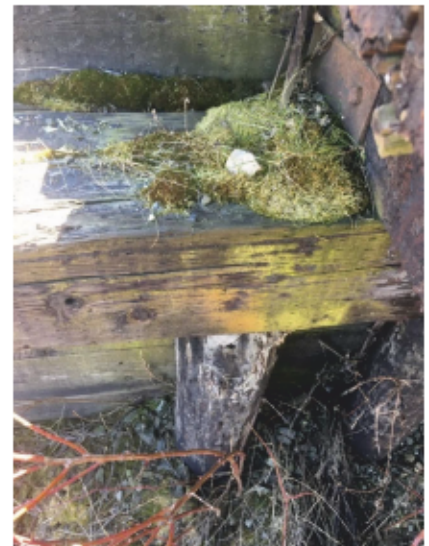
FIGURE 3.2.8-MOSS/MILDEW

moss and mildew from all material surfaces. If and damage, deterioration or rot were observed under the mold/moss consult BE. Annual maintenance to prevent the growth of moss and mildew may be required on all the bridges.

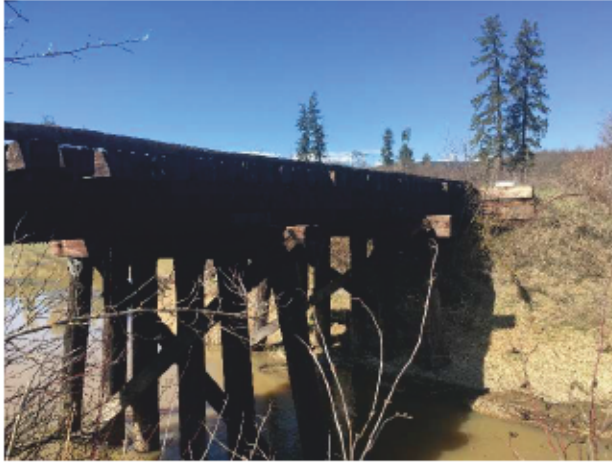
FIGURE 3.2.9-PILES

4. Piles-14" diameter treated piles {Figure 3.2.9}
  - a. Embedded into the earth or reiverbed at unknown depths.
  - b. There are 5 or 6 piles per bearing line.
  - c. Most columns have vertical alignment except the end piles of the middle bearing lines that are battered. Battered columns are at an angle to help provide stability and compensate for water thrust forces. {Figure 3.2.10}
  - d. Pile heights vary as grade varies with a maximum visible height of 7'-8".
  - e. The pile connection to the secondary beam was not visible. {Figure 3.2.11}
5. Cross Bracing-4"x8" creosote treated bracing members. {Figure 3.2.10}
  - a. Cross bracing observed on interior bearing lines only.
  - b. Typically, 1 brace per side in opposite orientated to create an "X".
  - c. Braces anchored with ¾" diameter thru bolts and large washers to piles. {Figure 3.2.12 & 3.2.13}

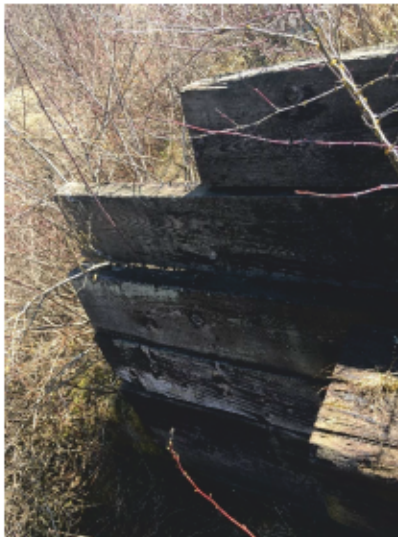
FIGURE 3.2.14 ABUTMENT A

6. Abutments-12" deep creosote treated built up members.
  - a. Overall the abutments for this bridge were in moderate to poor condition.
  - b. Abutment A (Grid Line 1 in Figure 3.1.3) is about 5'-0" or 5 visible courses high. This abutment showed signs of fatigue and deterioration. {Figure 3.2.14 and 3.2.15}
  - c. Abutment B (Grid Line 4 Figure 2.1.3) about 3'-0" or 3 visible courses high. This abutment showed signs of fatigue. {Figure 2.2.16}

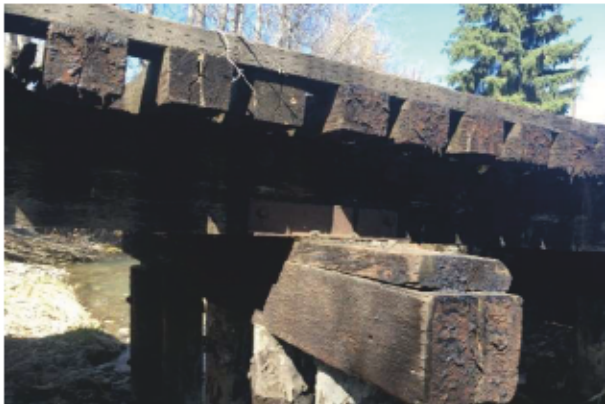
FIGURE 5.2.8-SECONDARY BEAM &amp; CONNECTION

- c. Overall beam condition is moderate except for bearing line 3, as noted on grid line 3- Figure 5.1.3. The south end of the secondary beam show signs of deterioration and rot. {Figure 5.2.9}
- d. 6"x4" angle iron connections are used to anchor the main beam and secondary beam. {Figure 5.2.8}

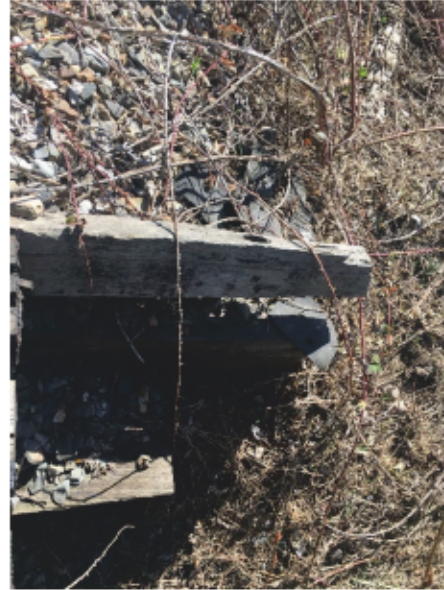
FIGURE 5.2.15-ABUTMNET B

5. Abutments- 4"x12" creosote treated built up members.
  - a. Overall the abutments for this bridge are in poor condition.
  - b. Abutment A (Grid Line 1 in Figure 5.1.3) is about 6'-0" or 6 visible courses high and showed signs of fatigue. Only some of the abutment was visible behind bearing line 1. {Figure 5.2.14 & 5.2.16}
  - c. Abutment B (Grid Line 4 Figure 5.1.3) about 4'-0" or 4 visible courses high. This abutment showed signs of fatigue and deterioration. There were noticeable gaps between the abutment members allowing the ground material to penetrate. {Figure 5.2.15 & 5.2.17}
